**Hazardous Materials Assessment Report
Courtesy Parkway Extension
Courtesy Ford Collision Center
267 Penske Dr SE
Conyers, Rockdale County, GA 30013**

**Corporate Environmental Risk Management, LLC (CERM)
1990 Lakeside Parkway
Tucker, GA 30084
Project No. 2023-1470D-003D**

October 13, 2023

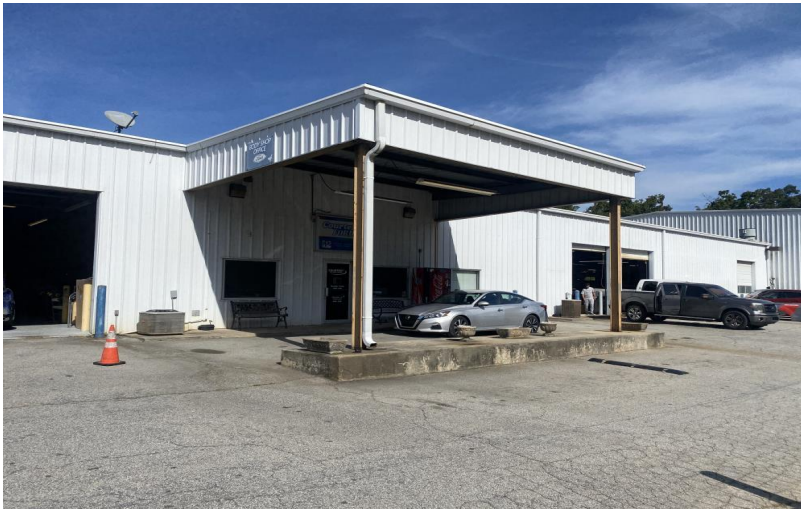
Photo 1
Comments: Main entrance

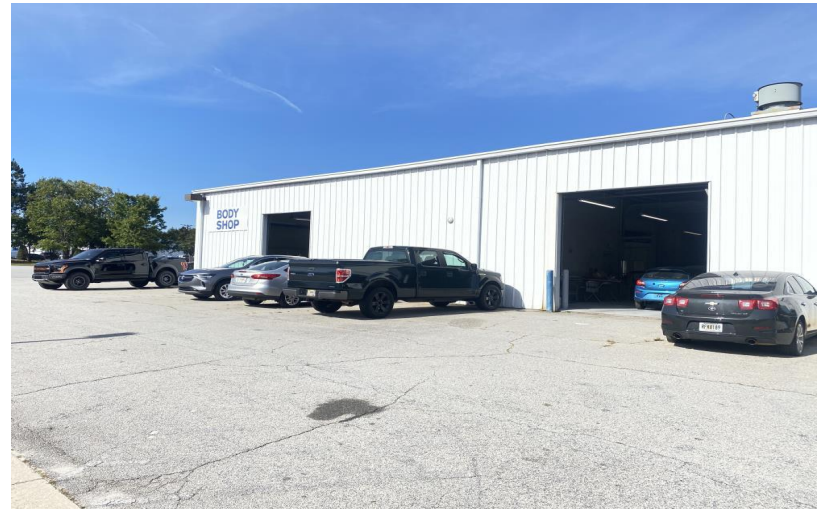
Photo 2
Comments: Paint area south exterior

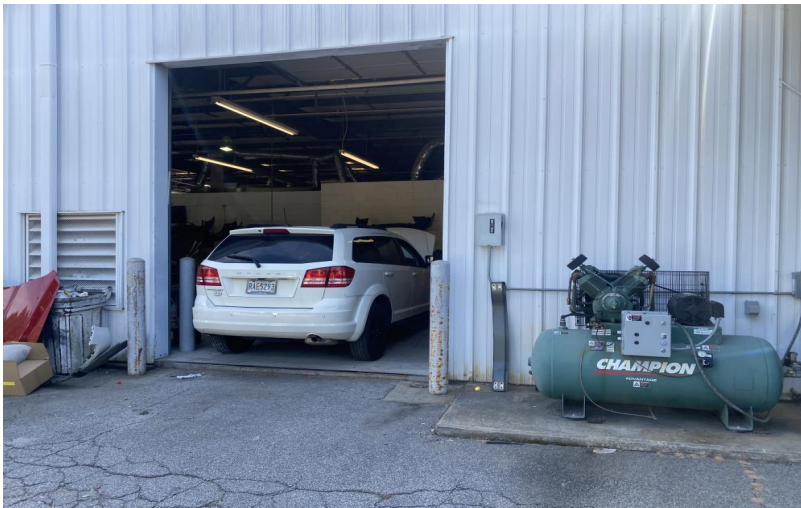
Photo 3
Comments: Body shop North exterior

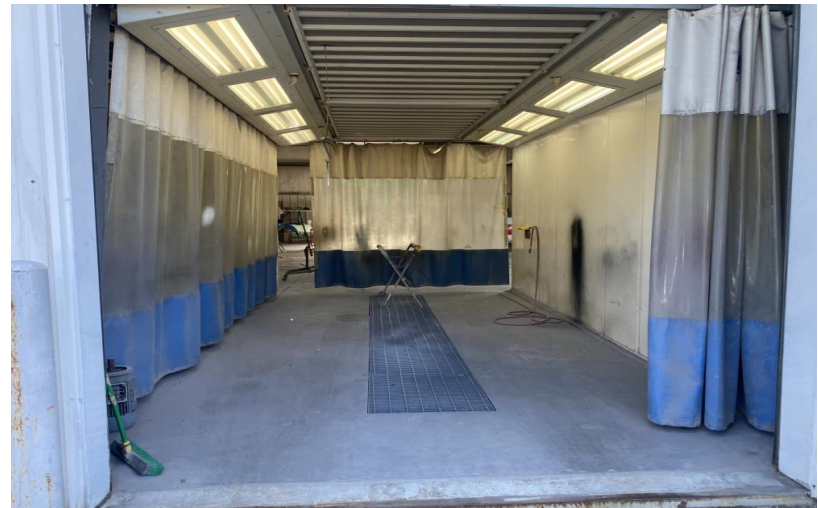
Photo 4
Comments: Painting booth

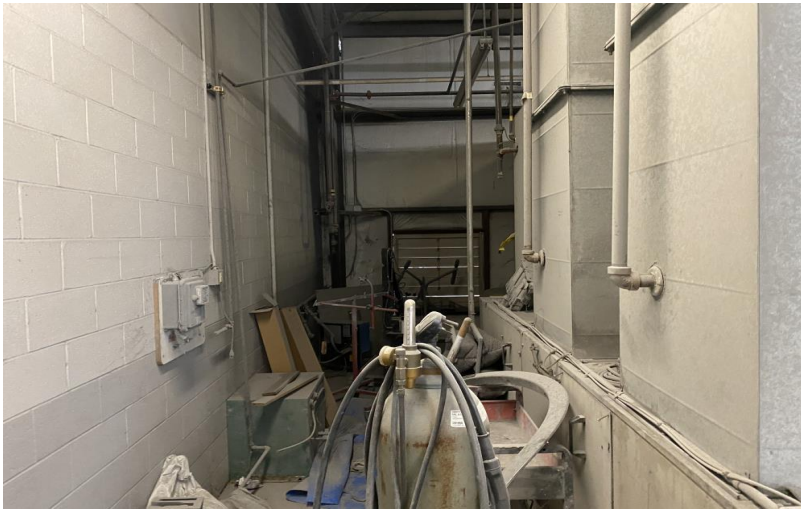
Photo 5
Comments: Paint booth ventilation

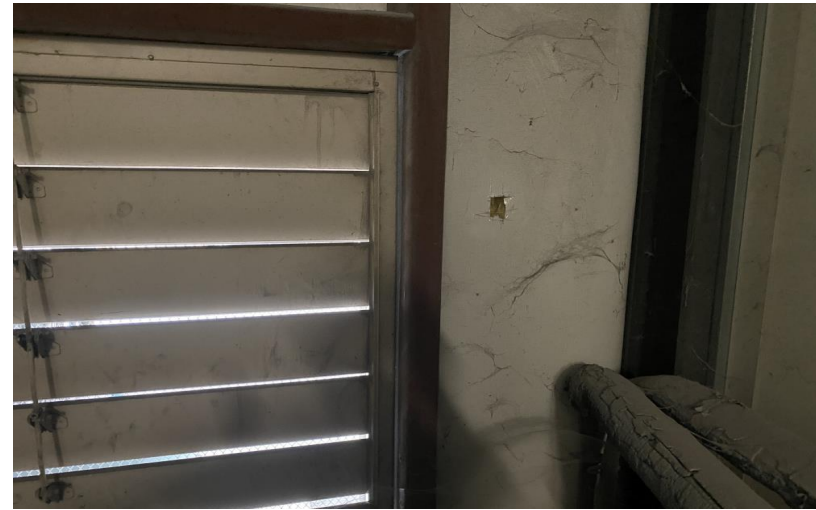
Photo 6
Comments: Wall insulation sample

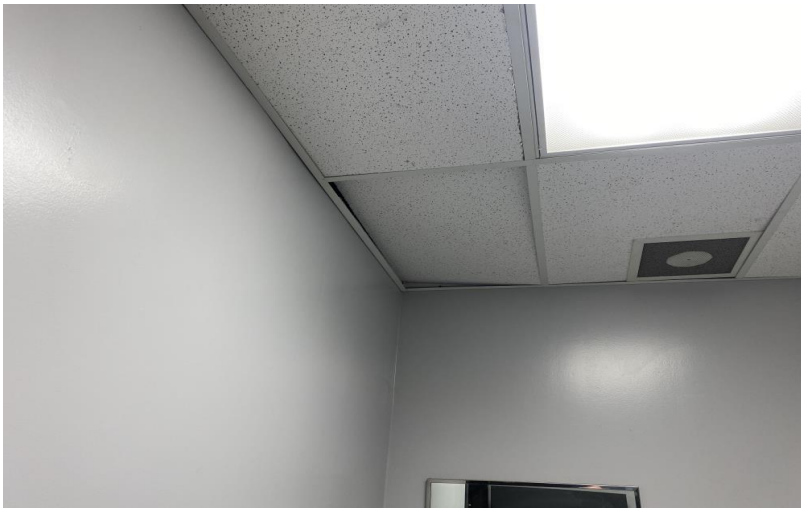
Photo 7
Comments: Office ceiling tiles

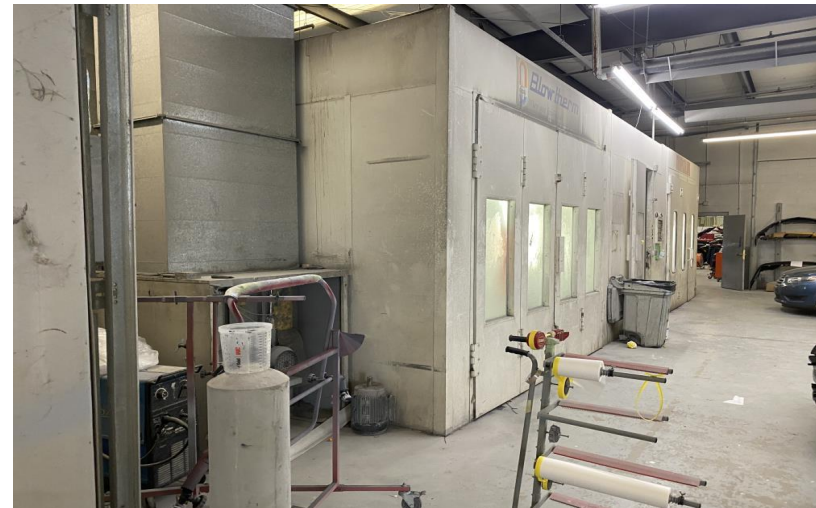
Photo 8
Comments: Paint booths

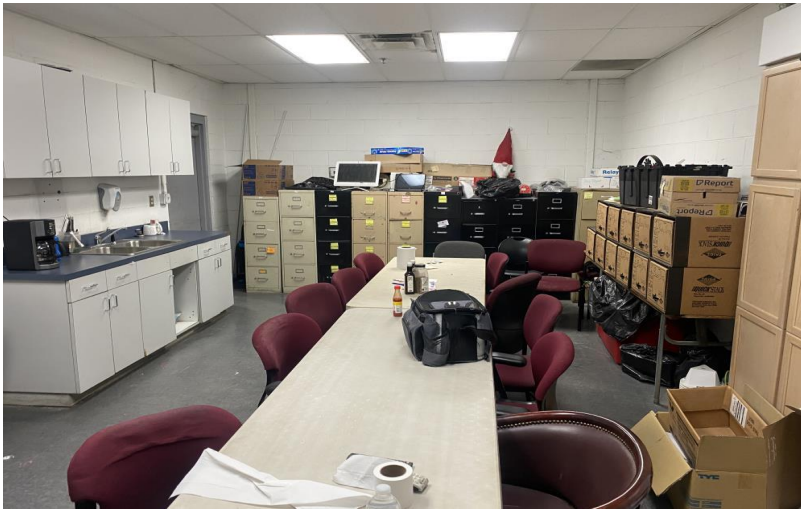
Photo 9
Comments: Break room

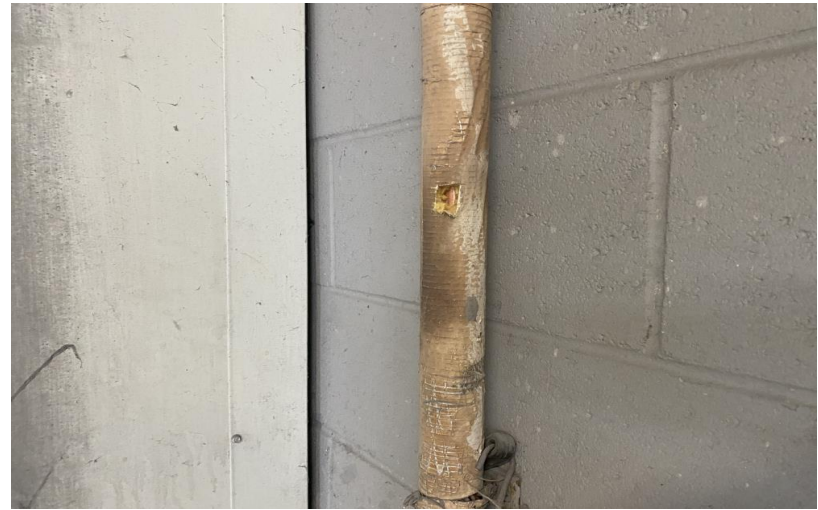
Photo 10
Comments: Pipe insulation

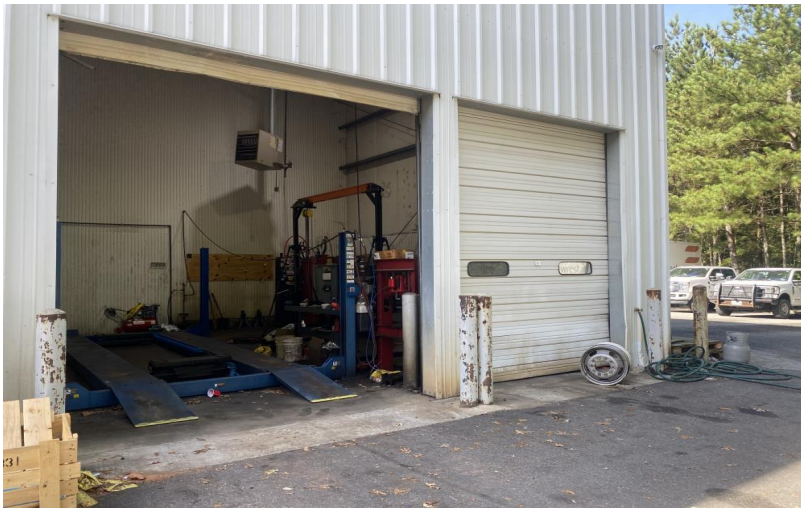
Photo 11
Comments: Diesel area east exterior

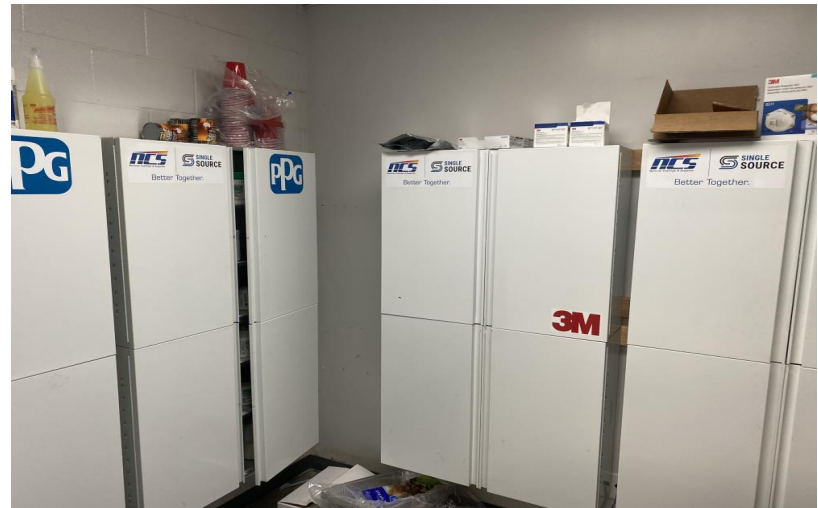
Photo 12
Comments: Break room storage

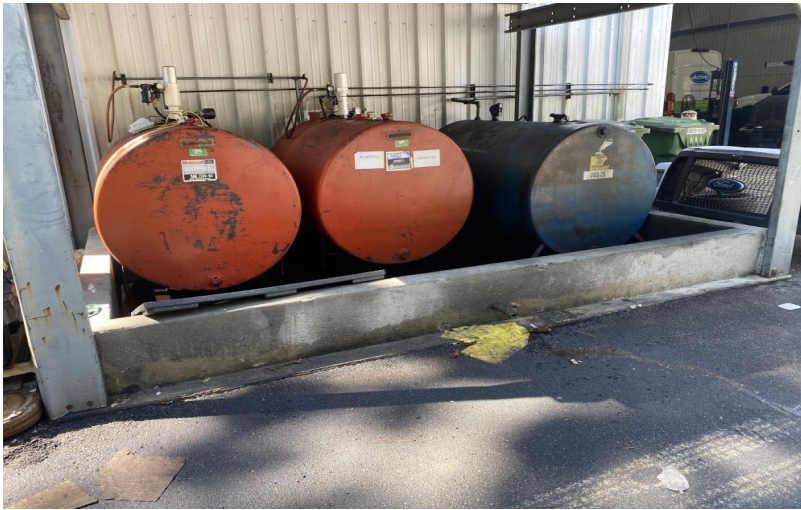
It is worth noting that other regulated and/or potential hazardous chemicals were observed as likely present at the subject property. However, they are expected to be removed by the current occupant upon move-out. These include the following:

Photo 13
Comments: Used oil tanks on north exterior

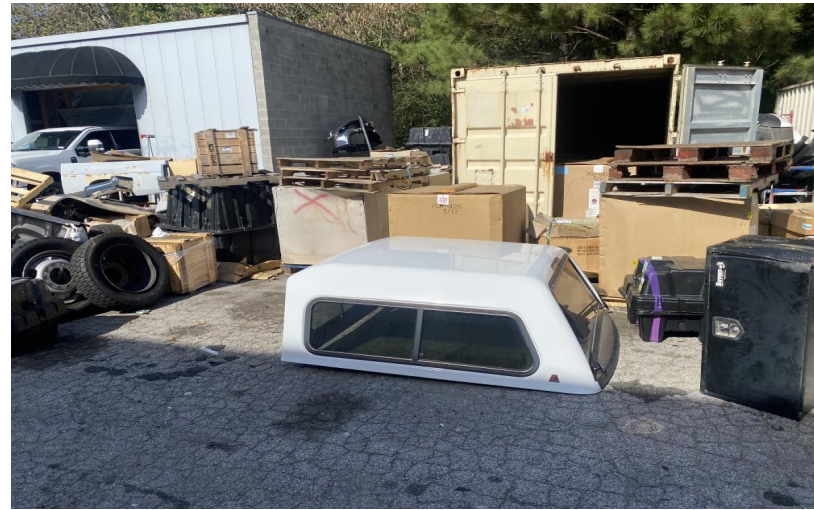
Photo 14
Comments: Bed lining shed and loose parts

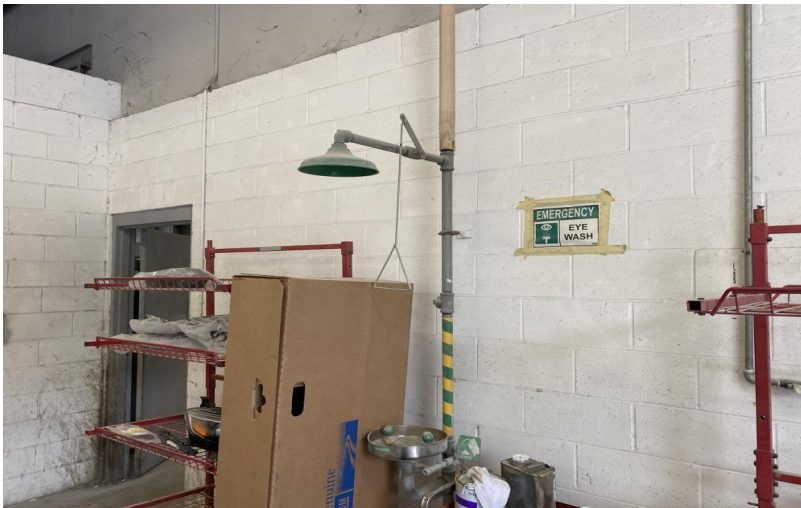
Photo 15
Comments: Body shop area west wall and eye wash

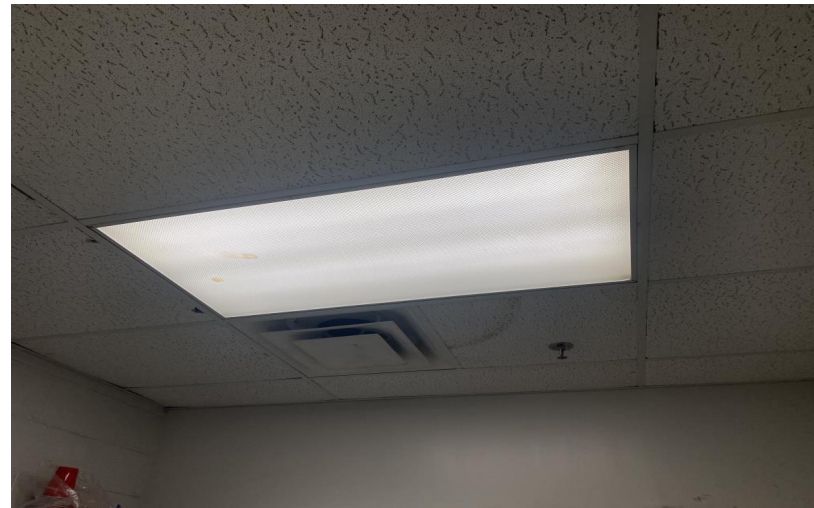
Photo 16
Comments: Break room light fixture

Any mercury-containing fluorescent light bulbs, mercury-containing thermostat components, and PCB light ballasts should be properly disposed in accordance with Georgia Solid Waste Rules.

CERM recommends that fluorescent light bulbs and mercury-containing thermostats, where applicable, be submitted to a licensed recycling facility. These items should be contained in sealed packages for transport. EPA recommends that these items be handled by trained professionals. CERM recommends that all suspect PCB-containing light ballasts be removed, contained in sealed drums and shipped to a licensed incineration facility for disposal. For occupied facilities, federal law requires that any suspect PCB-containing light ballasts that are found to be leaking be immediately removed and disposed of. Department of Transportation (DOT) requirements may also apply.

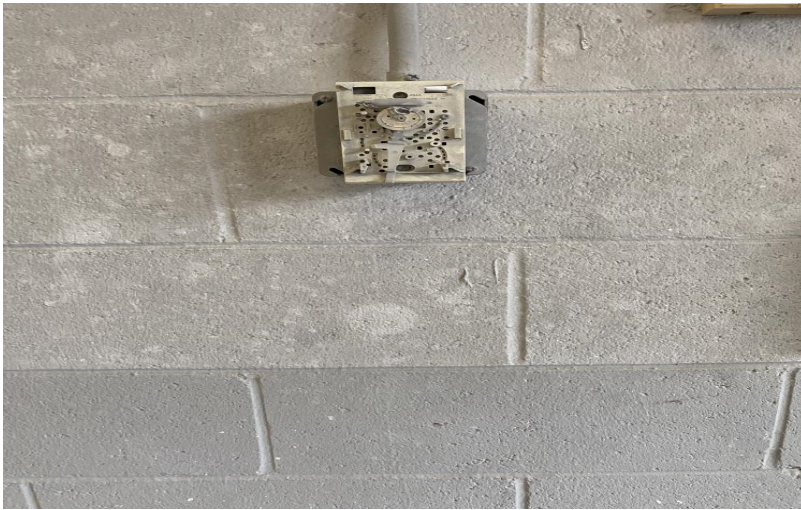
Photo 17
Comments: Mercury-containing thermostat

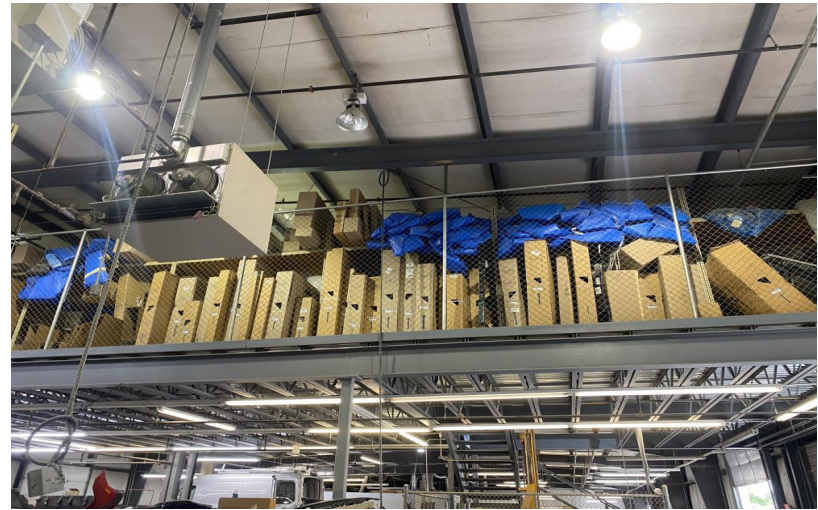
Photo 18
Comments: Second floor

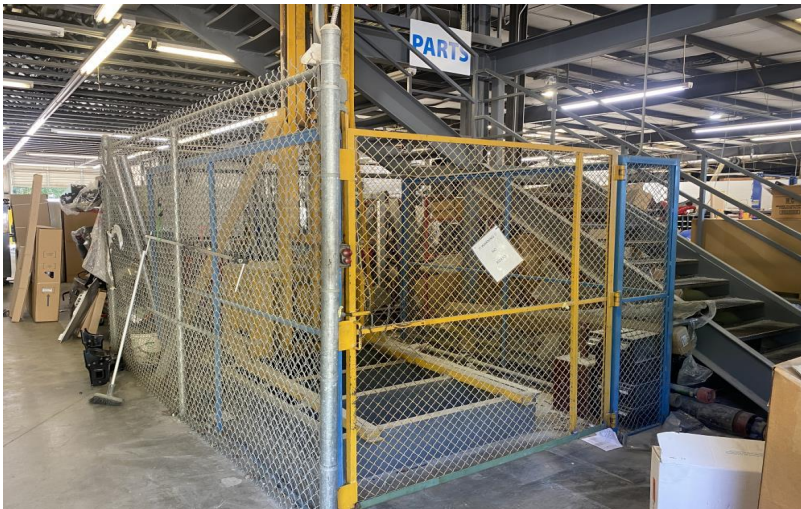
Photo 19
Comments: Lift to second floor

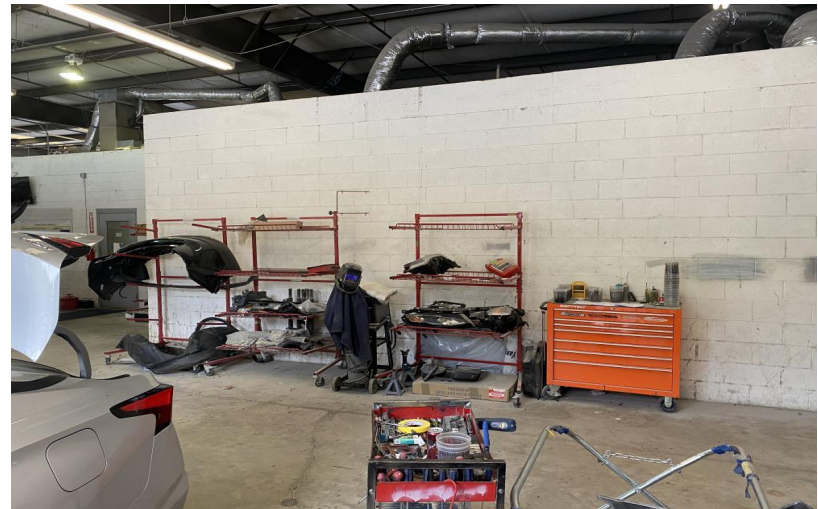
Photo 20
Comments: Wall between break room and body shop area

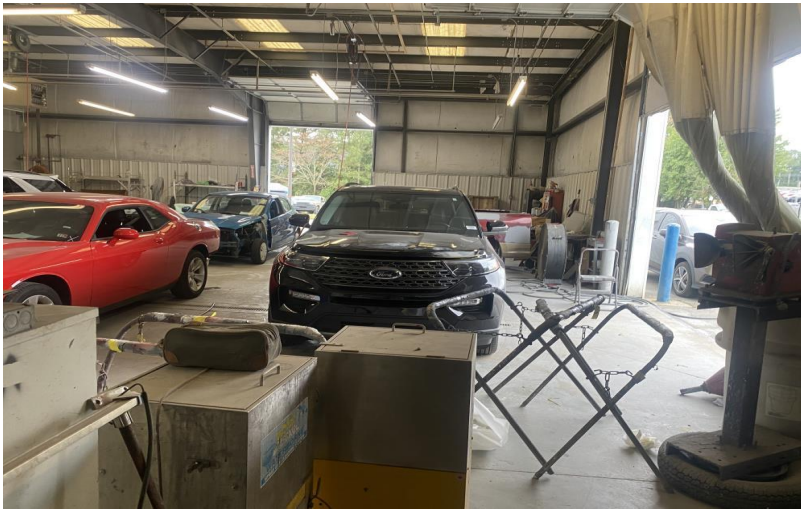
Photo 21
Comments: West paint area

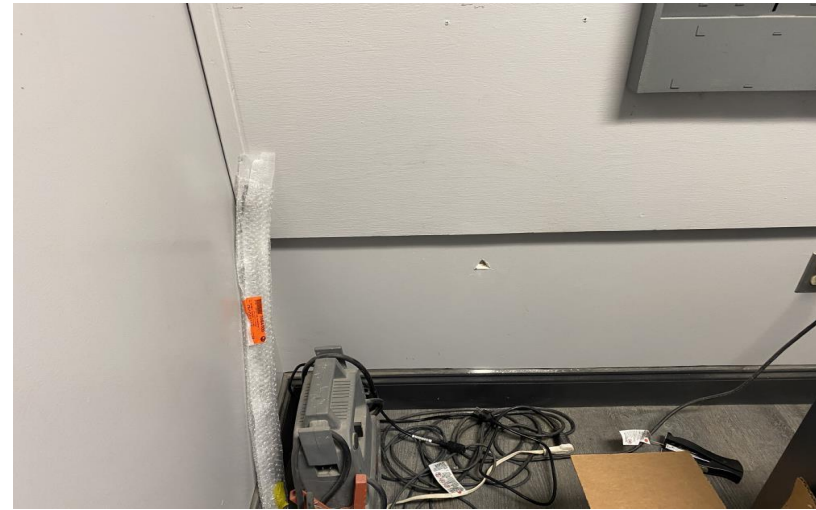
Photo 22
Comments: Office drywall sample

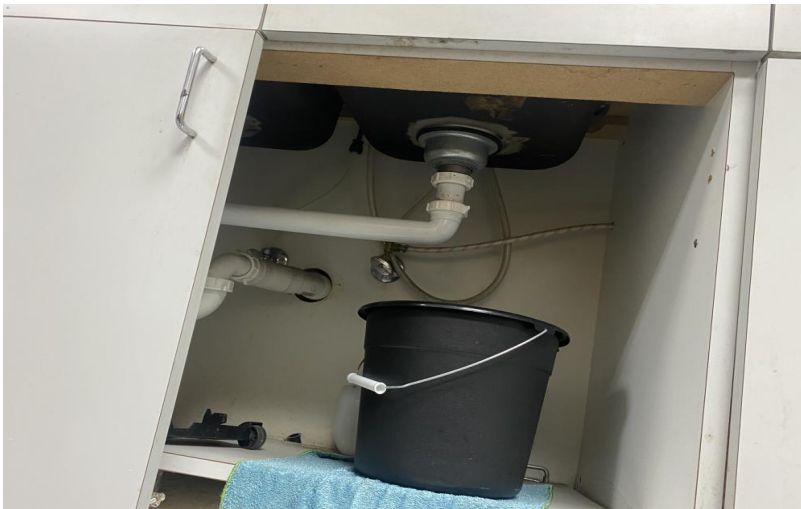
Photo 23
Comments: Sink insulation in break room

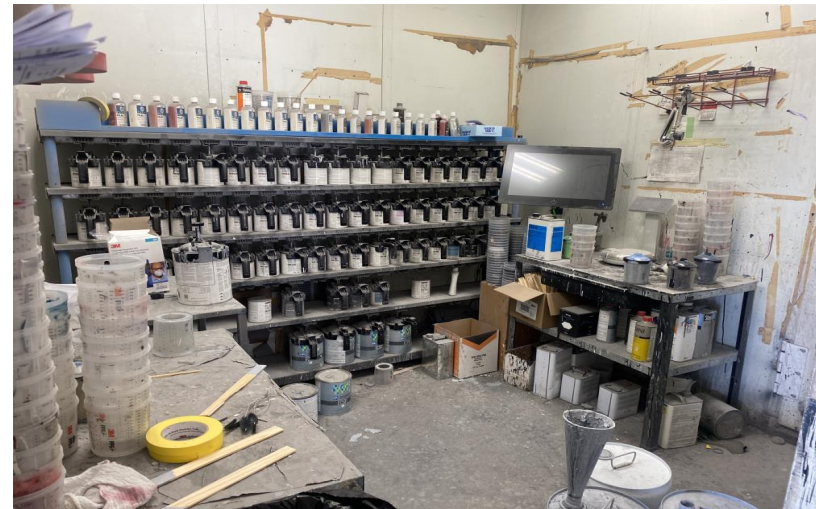
Photo 24
Comments: Paint storage

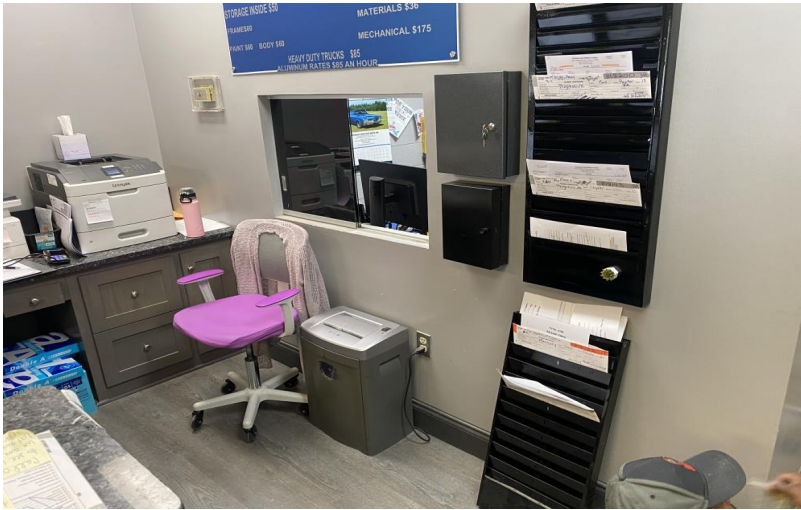
Photo 25
Comments: Front desk

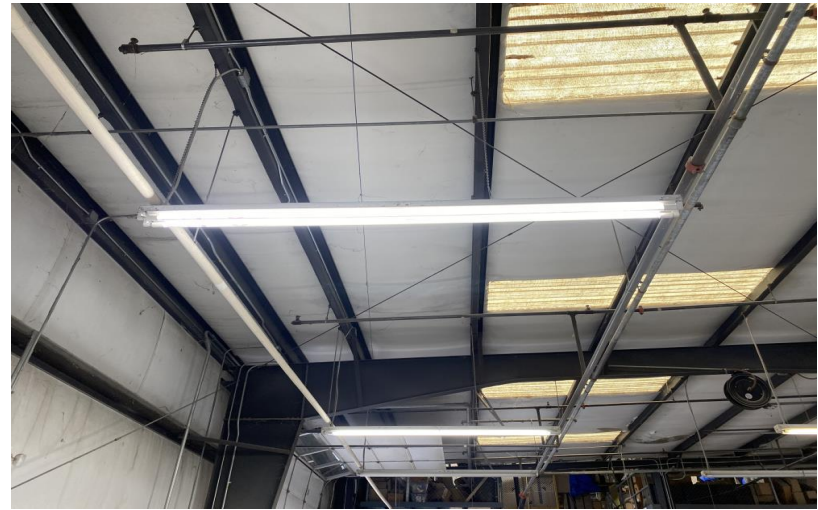
Photo 26
Comments: Body shop area lights

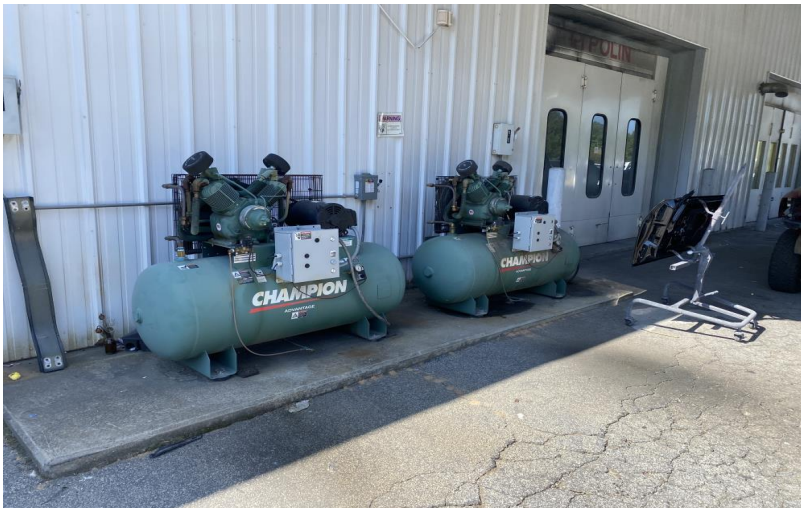
Photo 27
Comments: Air Compressors
