**Hazardous Materials Assessment Report
Courtesy Parkway Extension
MPrint USA
1680 Dogwood Drive
Conyers, Rockdale County, GA 30013**

**Corporate Environmental Risk Management, LLC (CERM)
1990 Lakeside Parkway
Tucker, GA 30084
Project No. 2023-1470D-001D**

October 13, 2023

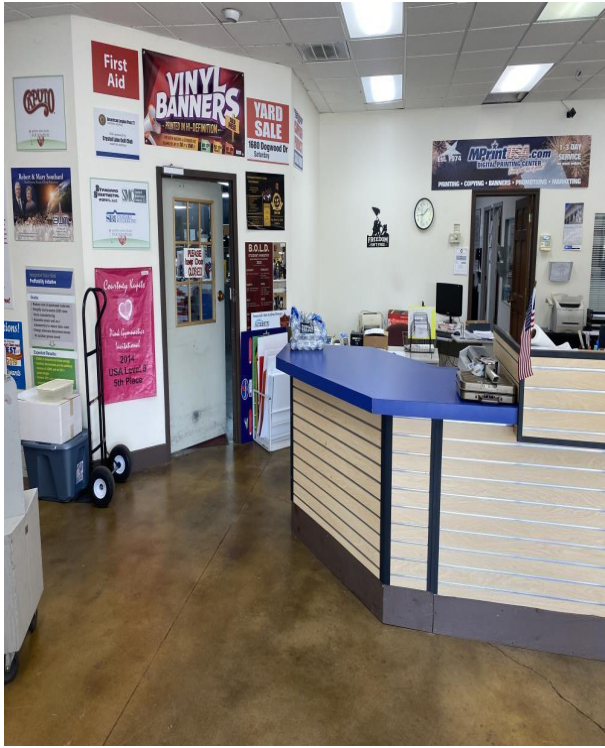
Photo 1
Comments: Print shop reception and production room entrance

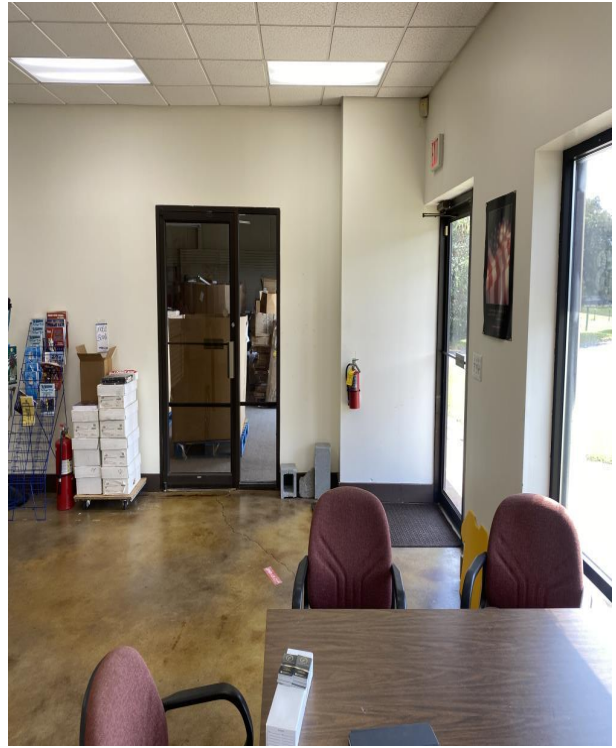
Photo 2
Comments: Entrance and door to storage area

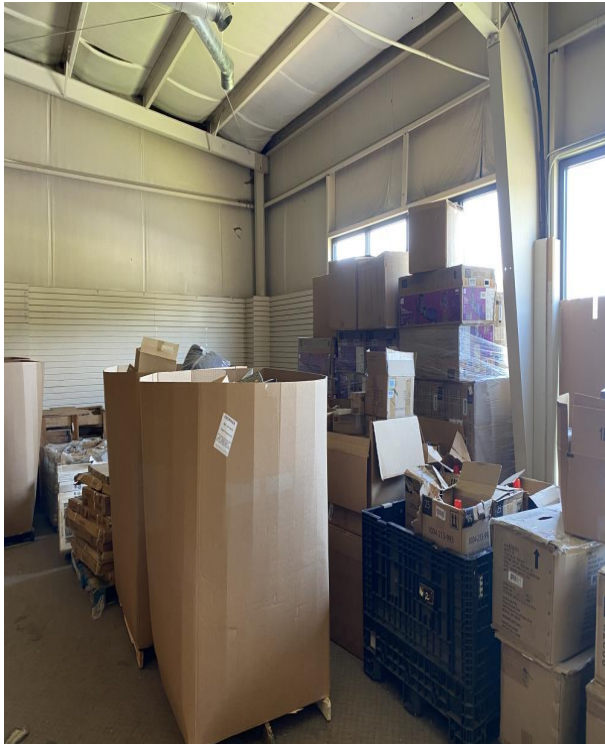
Photo 3
Comments: Storage area

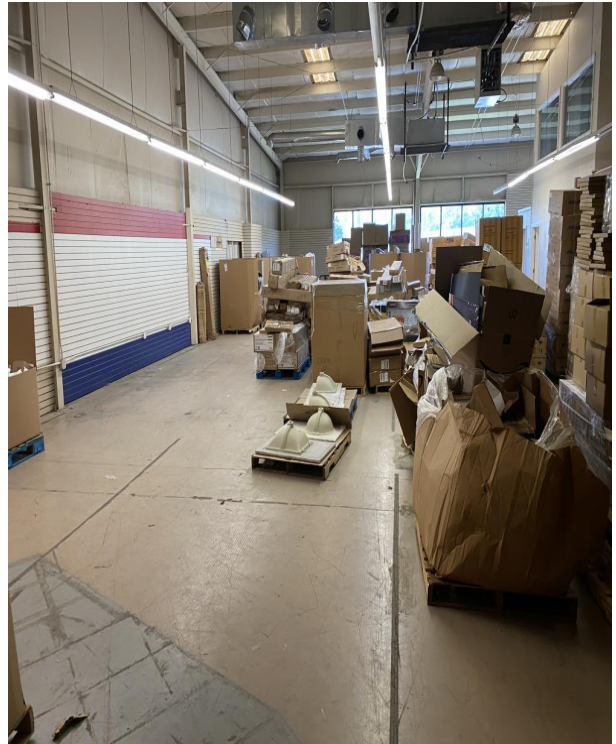
Photo 4
Comments: East storage room

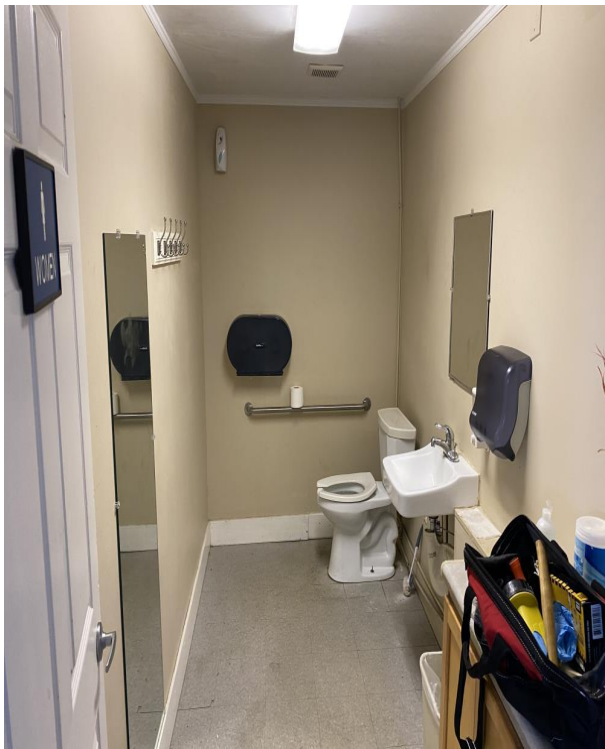
Photo 5
Comments: Bathroom in storage area

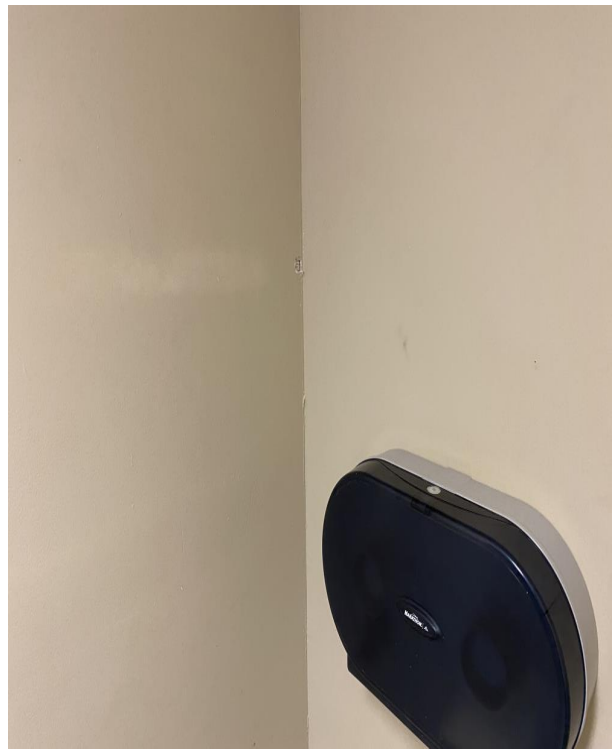
Photo 6
Comments: Drywall/Joint material in bathroom

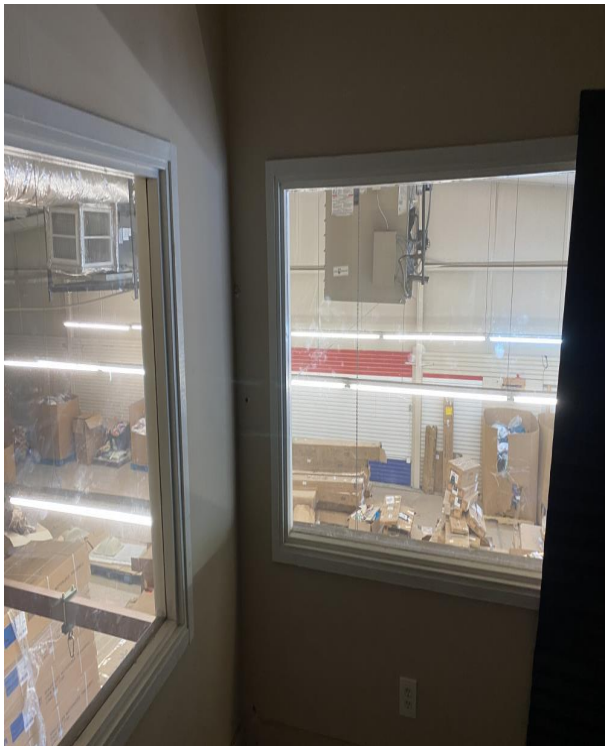
Photo 7
Comments: East storage second floor

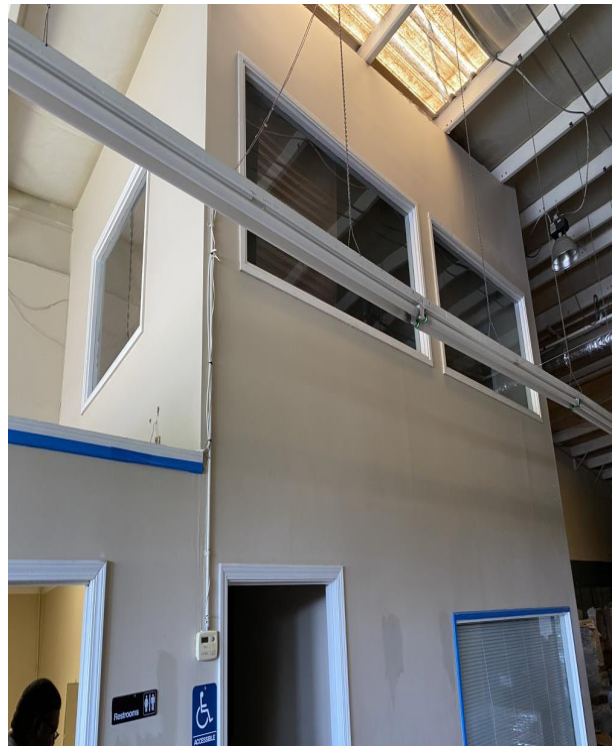
Photo 8
Comments: Fluorescent light fixtures in storage area

CERM recommends that fluorescent light bulbs and mercury-containing thermostats, where applicable, be submitted to a licensed recycling facility. These items should be contained in sealed packages for transport. EPA recommends that these items be handled by trained professionals. CERM recommends that all suspect PCB-containing light ballasts be removed, contained in sealed drums and shipped to a licensed incineration facility for disposal. For occupied facilities, federal law requires that any suspect PCB-containing light ballasts that are found to be leaking be immediately removed and disposed of. Department of Transportation (DOT) requirements may also apply.

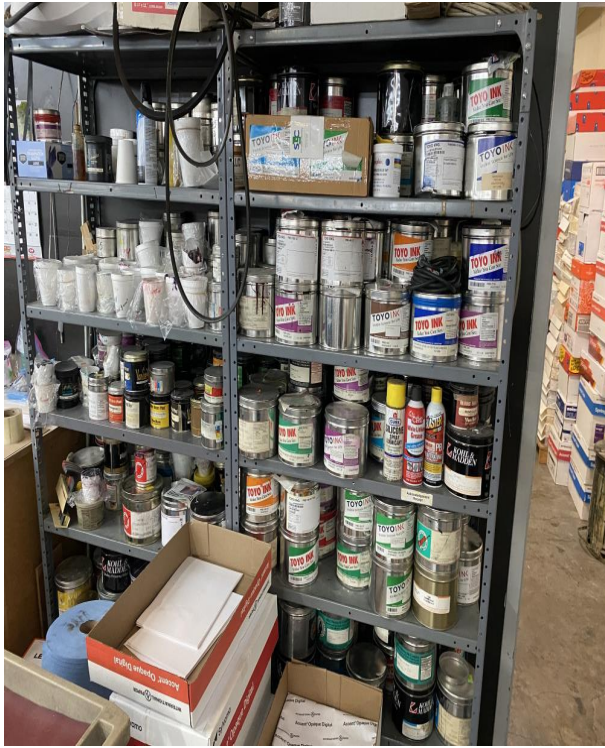
Photo 9
Comments: Ink storage shelf

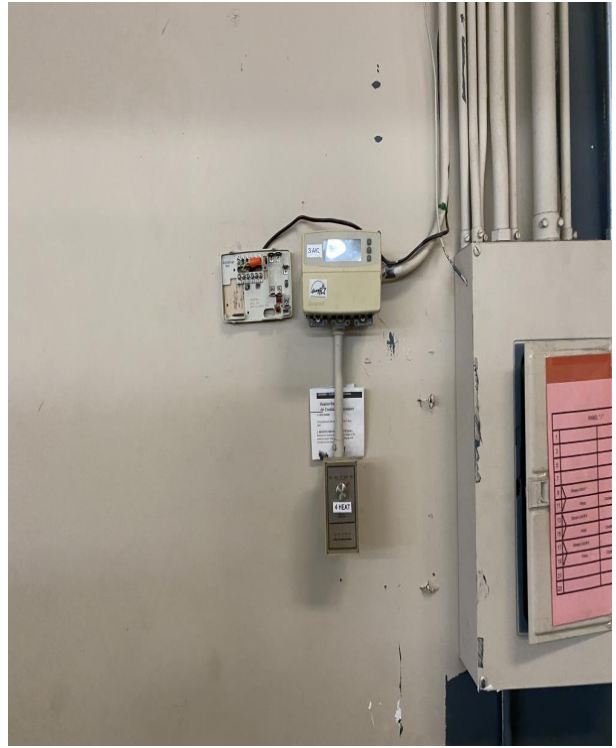
Photo 10
Comments: Thermostat in storage area

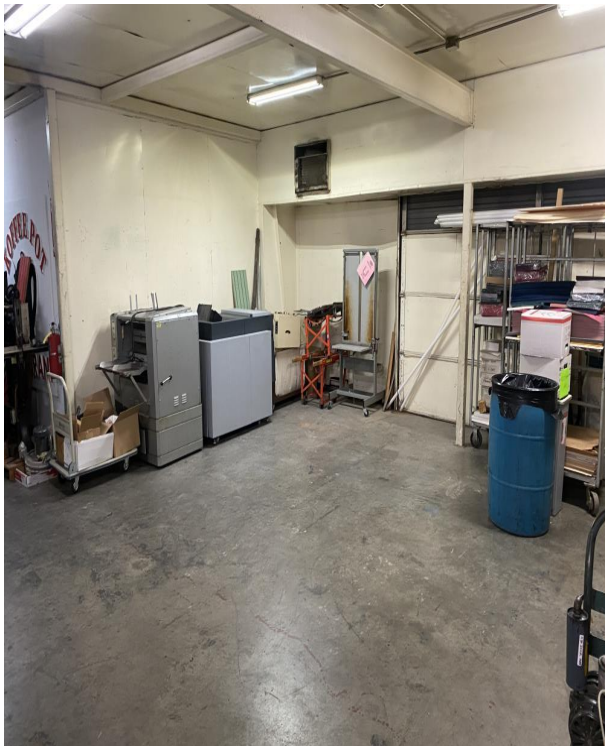
Photo 11
Comments: Room north of printing area

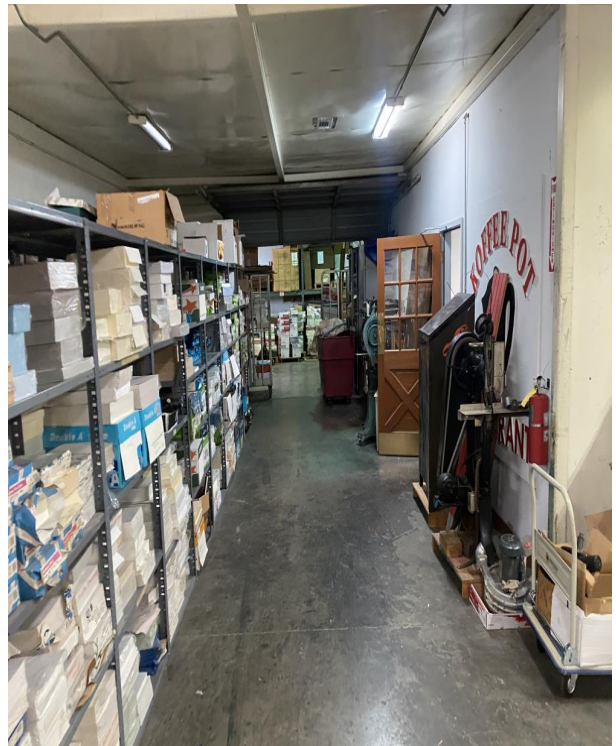
Photo 12
Comments: Area behind print room

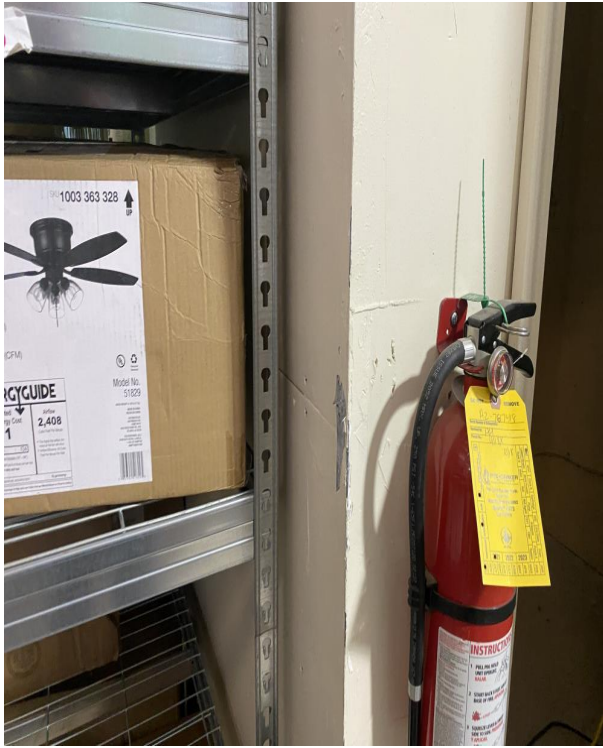
Photo 13
Comments: Thrift shop electronics room sample

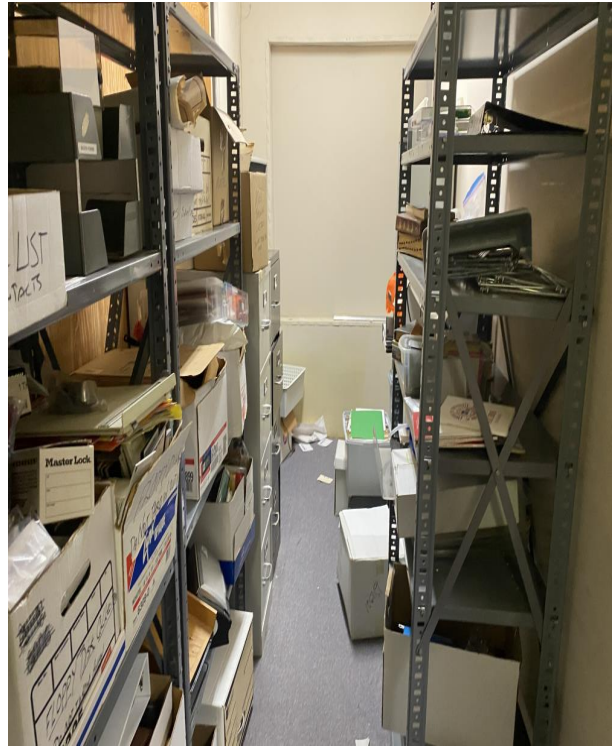
Photo 14
Comments: Print shop document storage area

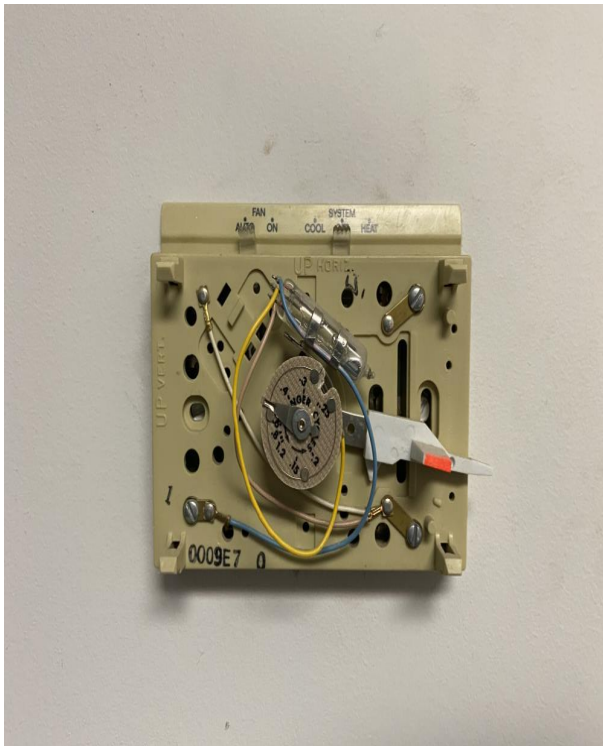
Photo 15
Comments: Mercury Containing Thermostat

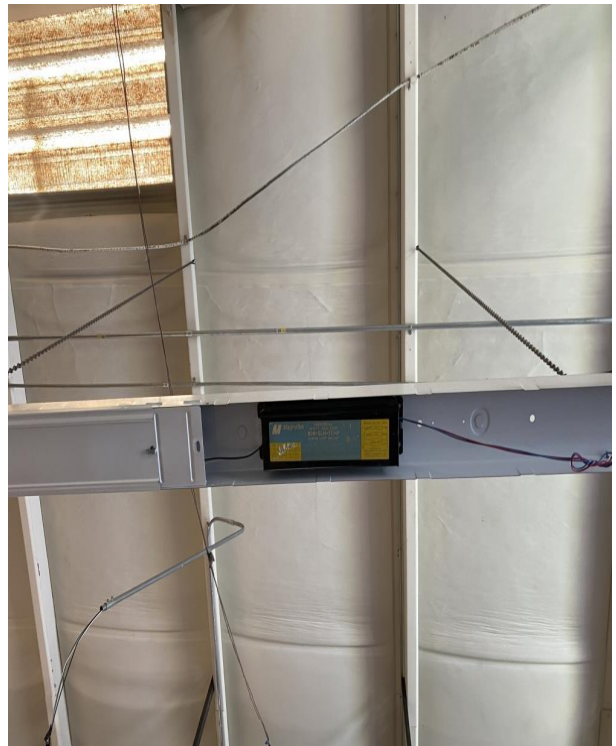
Photo 16
Comments: Non-PCB containing light ballast

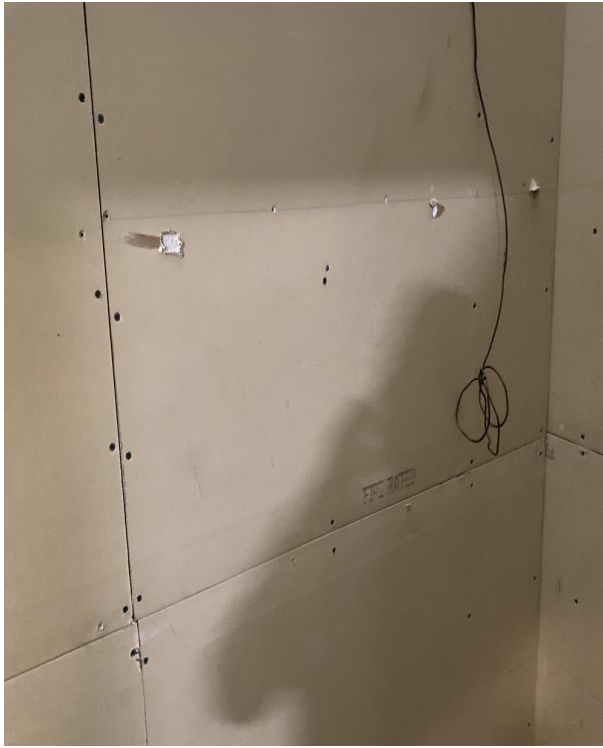
Photo 17
Comments: Drywall sample in thrift shop electronics room

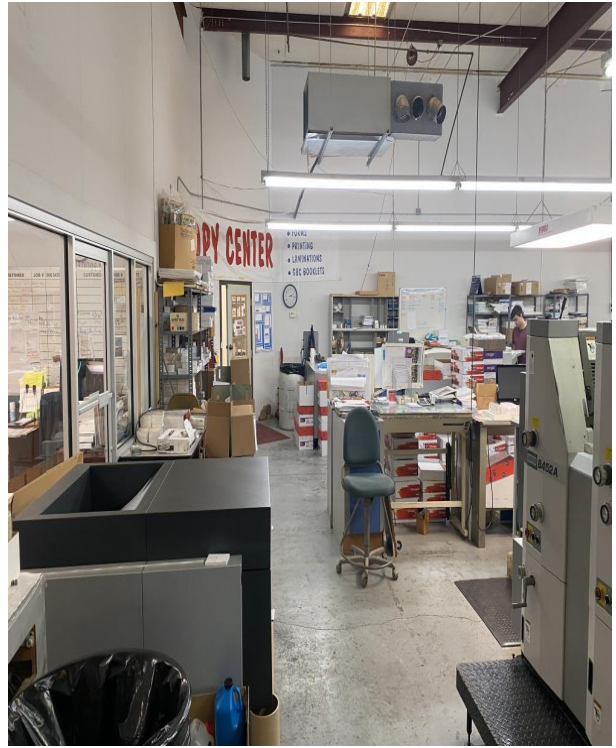
Photo 18
Comments: Print Shop production room

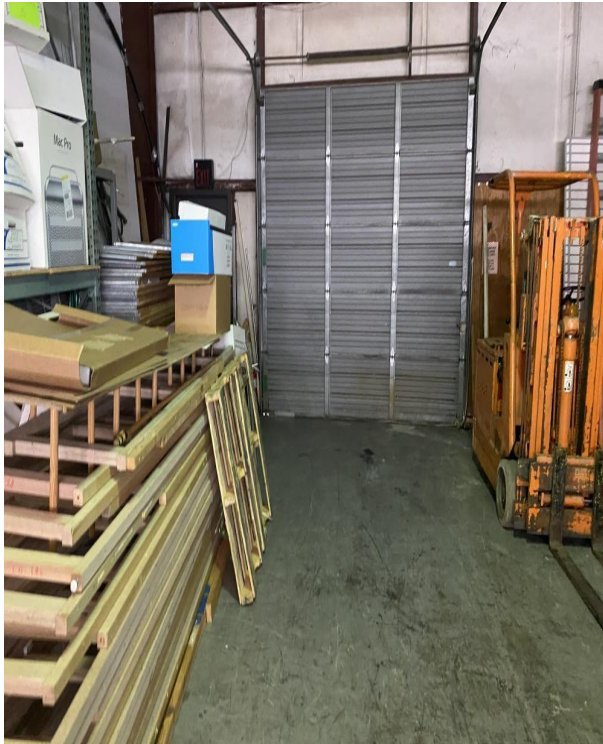
Photo 19
Comments: Loading area behind print production room

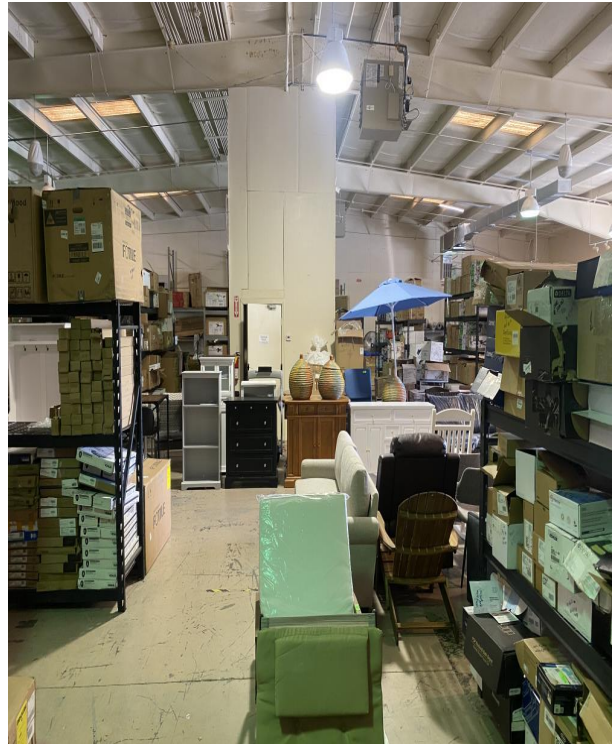
Photo 20
Comments: Thrift shop

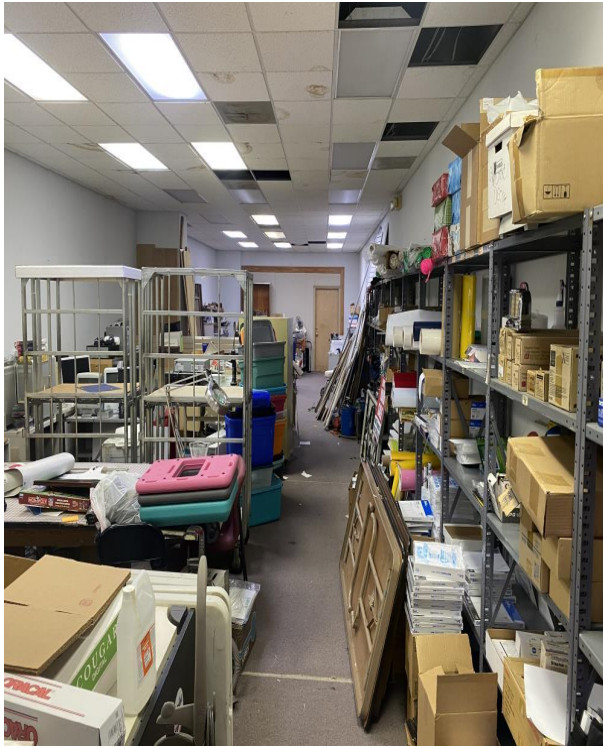
Photo 21
Comments: Storage room west of reception

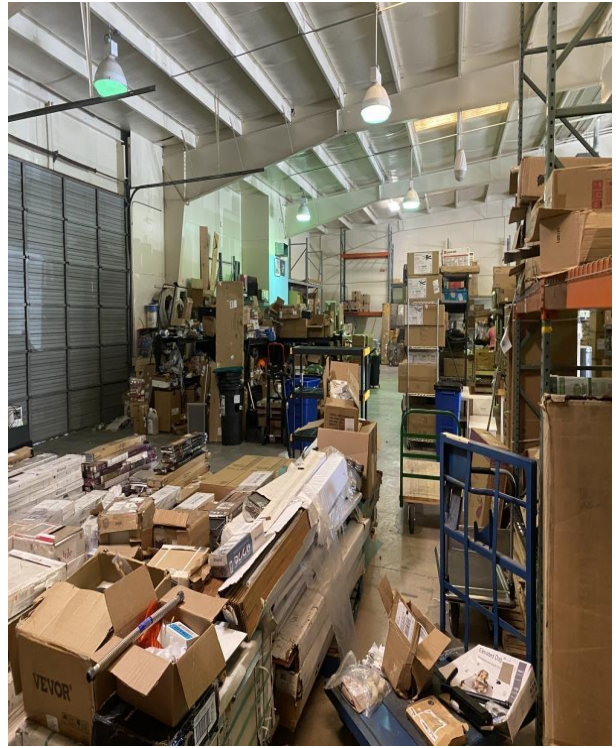
Photo 22
Comments: Back of thrift shop

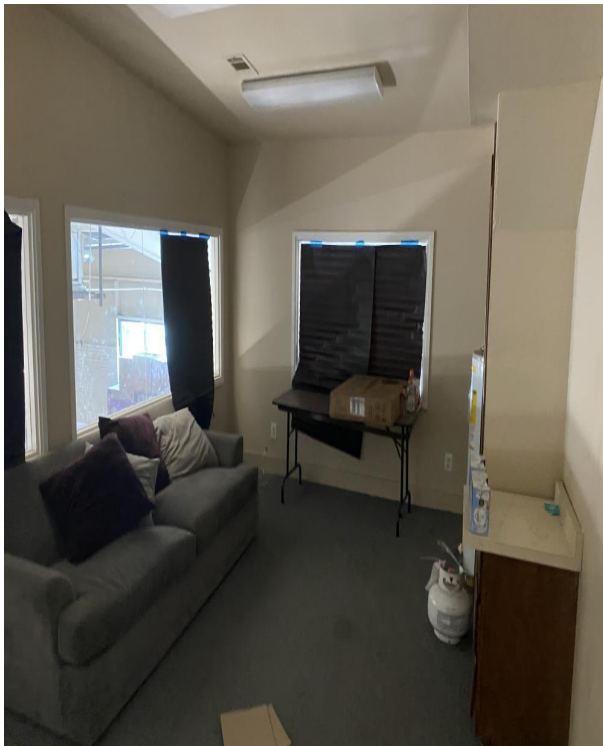
Photo 23
Comments: Second floor room in east storage area

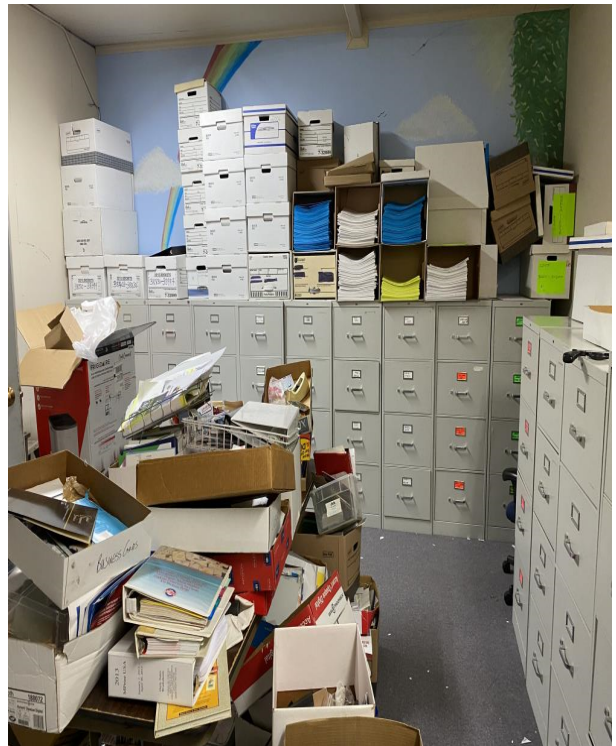
Photo 24
Comments: File storage

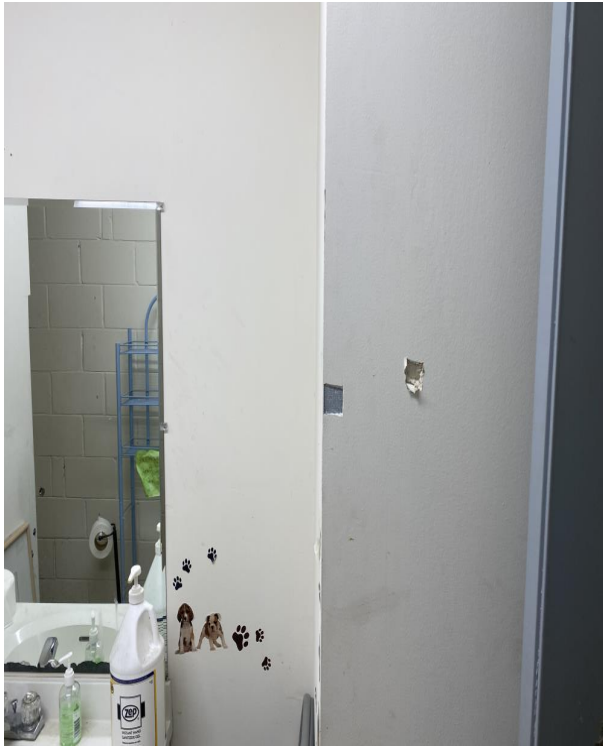
Photo 25
Comments: Sample locations in thrift store bathroom

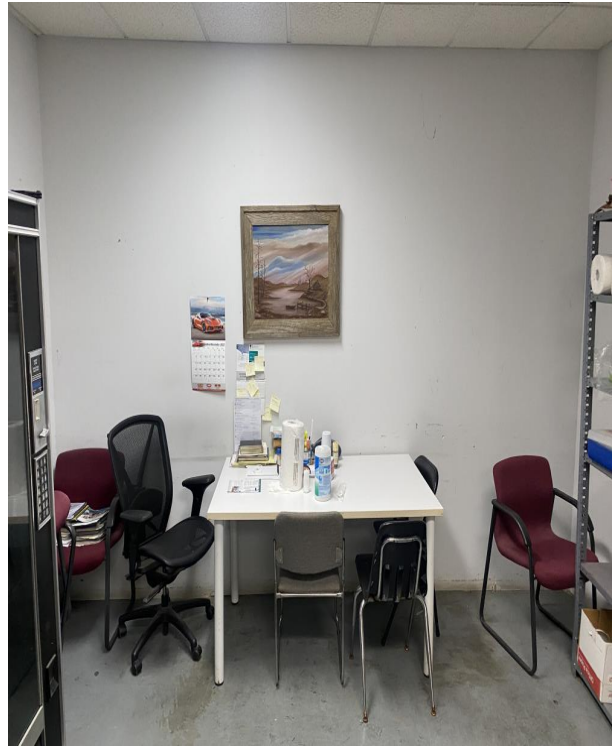
Photo 26
Comments: Break Room

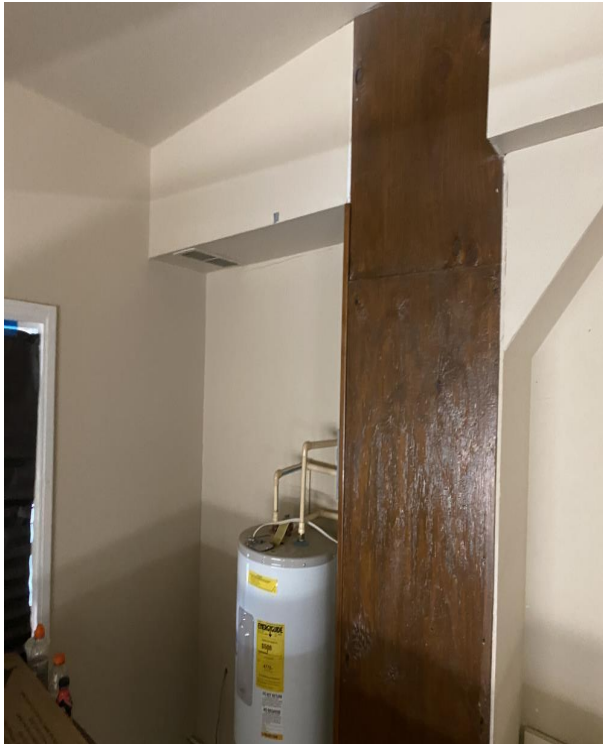
Photo 27
Comments: Storage room second floor

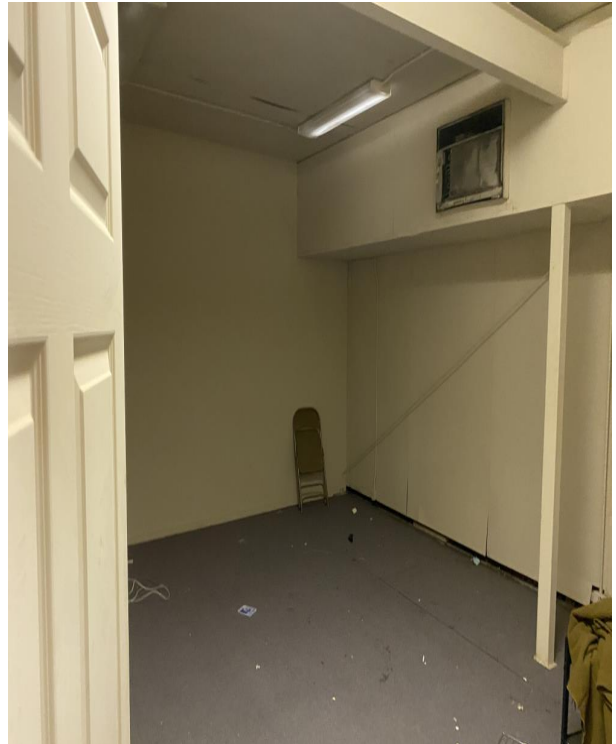
Photo 28
Comments: Vacant room north of design room
