**Hazardous Materials Assessment Report
Courtesy Parkway Extension
Springfield Baptist Church - Activity Center
1875 Iris Dr SE
Conyers, Rockdale County, GA 30013**

**Corporate Environmental Risk Management, LLC (CERM)
1990 Lakeside Parkway
Tucker, GA 30084
Project No. 2023-1470D-002D**

October 13, 2023

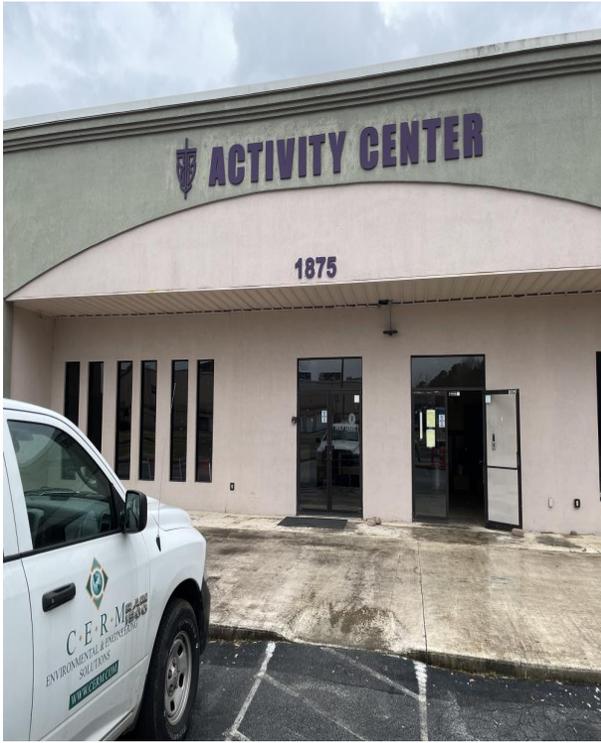
Photo 1
Comments: Main entrance

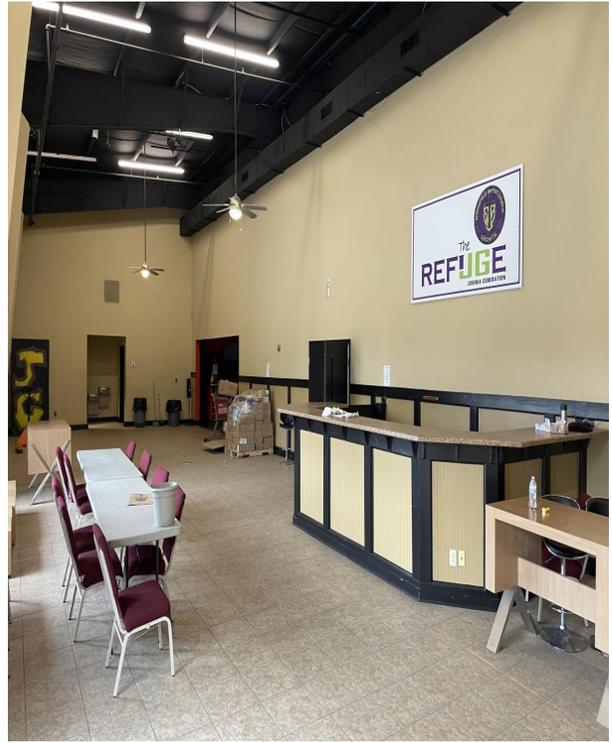
Photo 2
Comments: Lobby

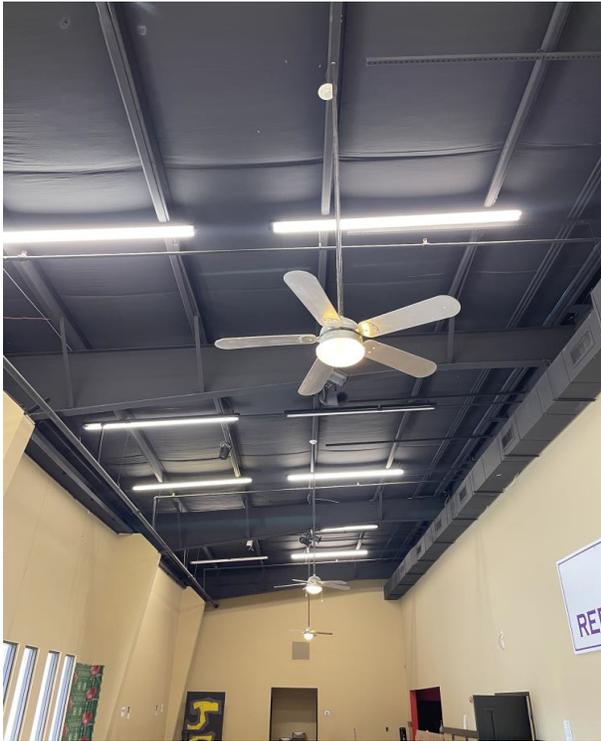
Light fixtures in the Lobby and Auditorium were inaccessible and categorized as suspect PCB light ballasts.

Photo 3
Comments: Lobby Ceiling and Light Fixtures

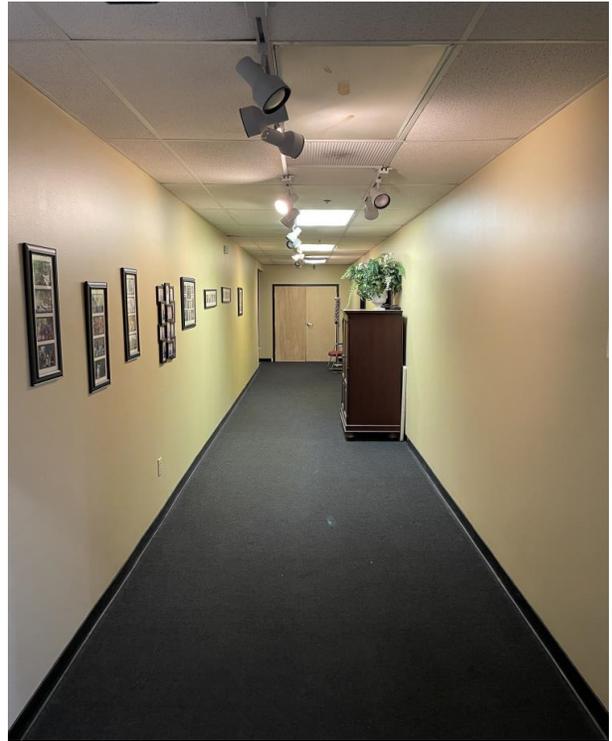
Photo 4
Comments: Lobby Offices Hallway

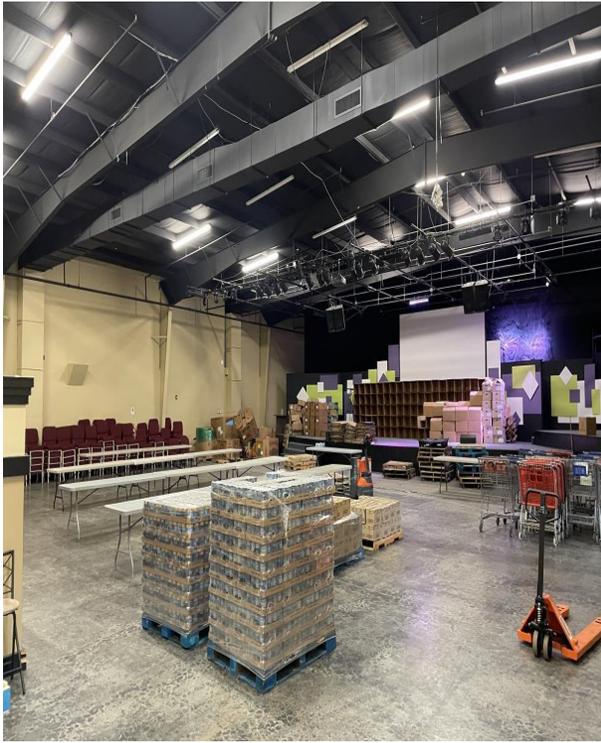
Photo 5
Comments: Auditorium

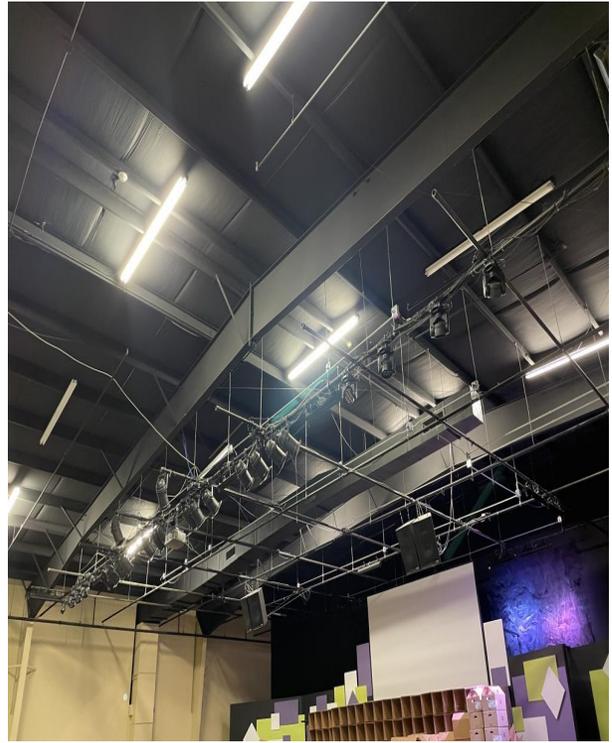
Photo 6
Comments: Auditorium

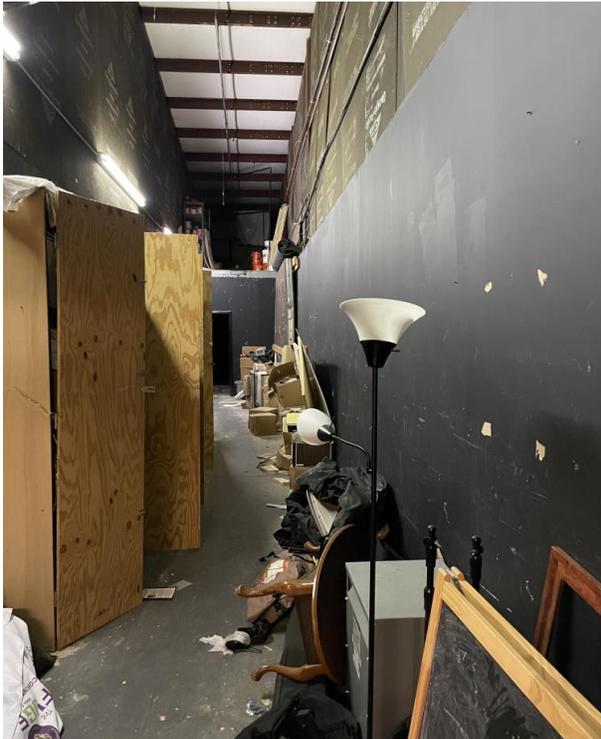
Photo 7
Comments: Backstage area

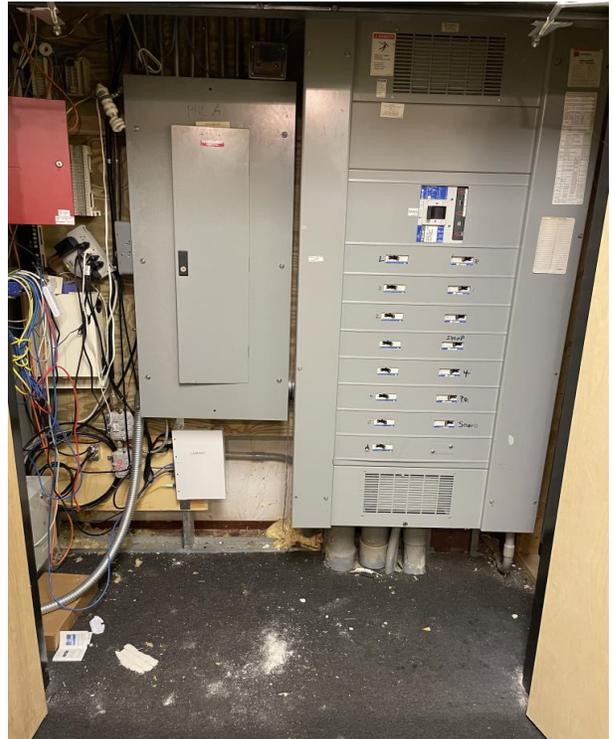
Photo 8
Comments: Electrical Panels

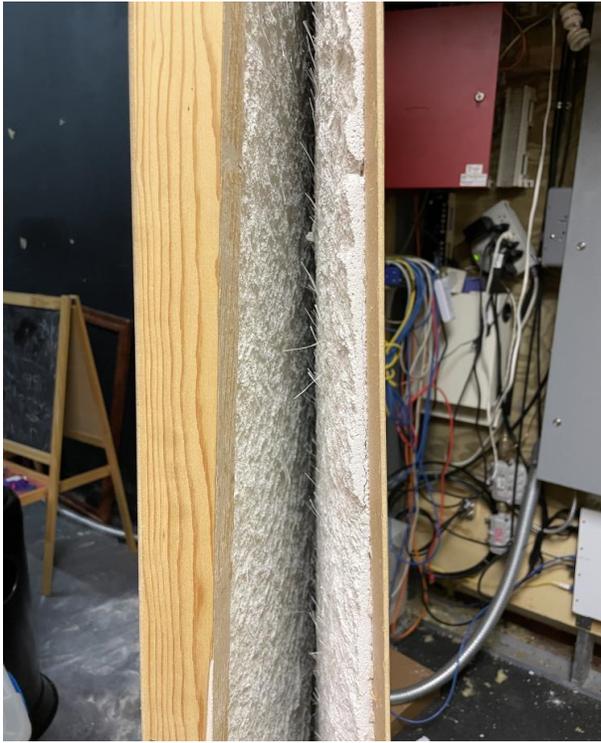
Photo 9
Comments: Fire Door Insulation (Non-Asbestos)

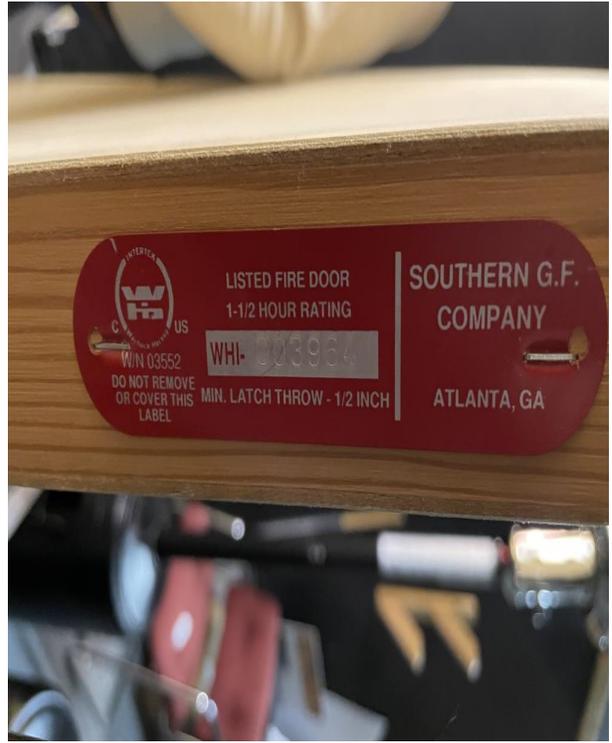
Photo 10
Comments: Fire Door Label

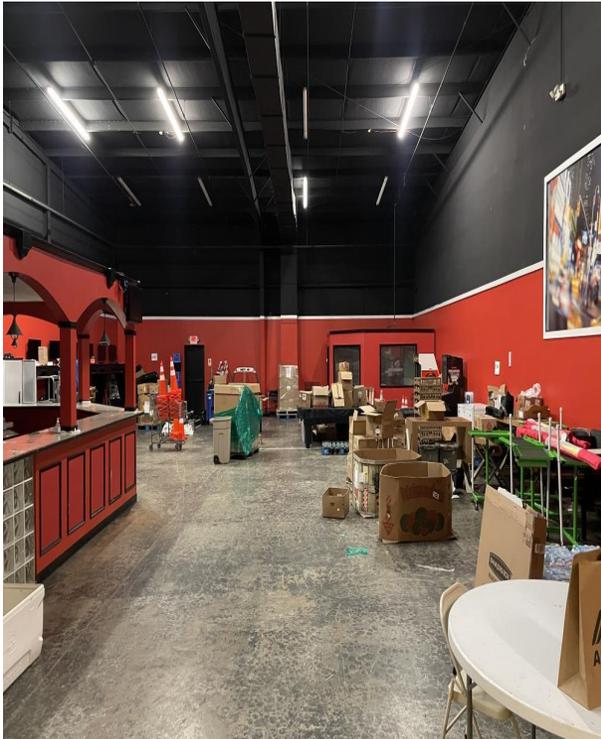
Photo 11
Comments: East Activity Room

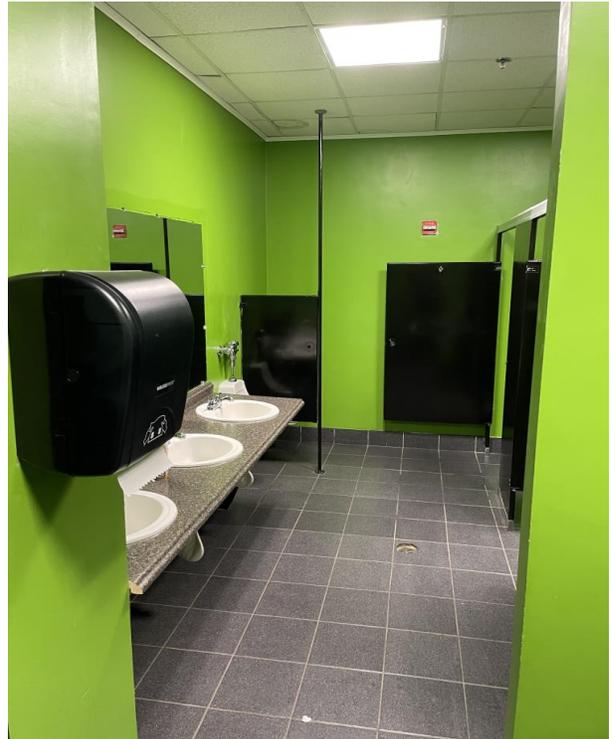
Photo 12
Comments: Men's Bathroom

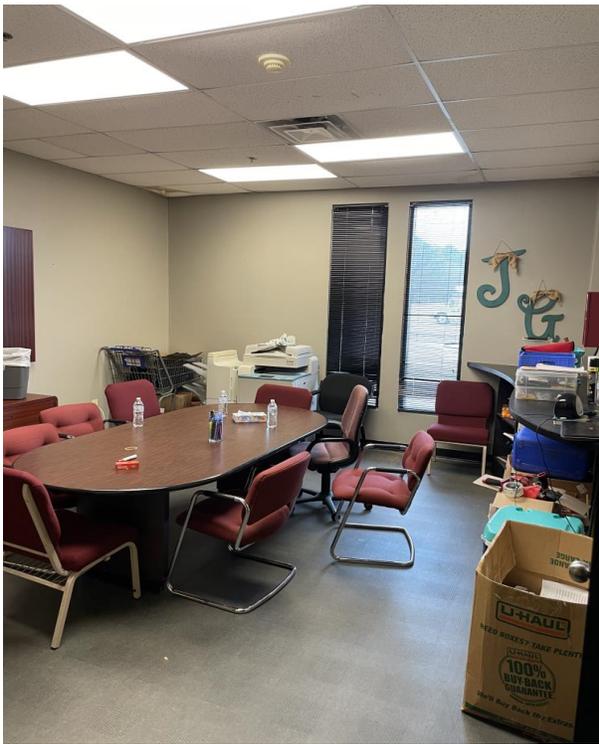
Photo 13
Comments: Conference Room/Office

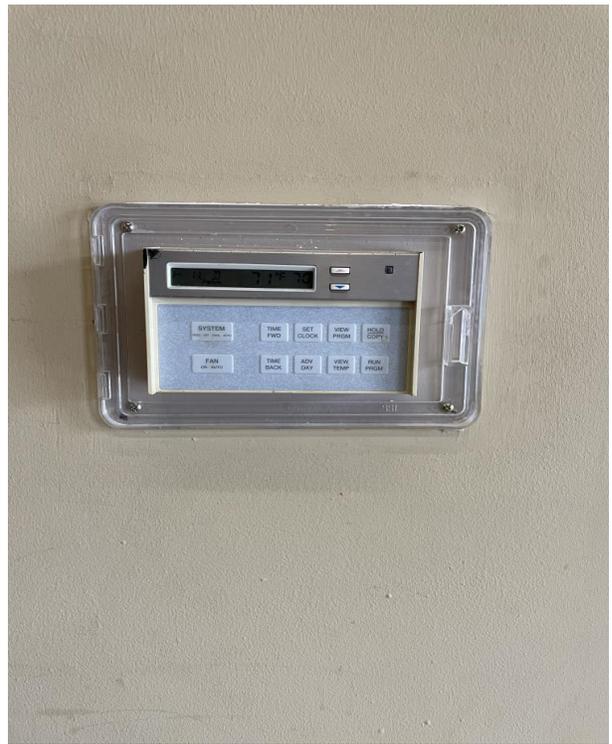
Photo 14
Comments: Security System Panel

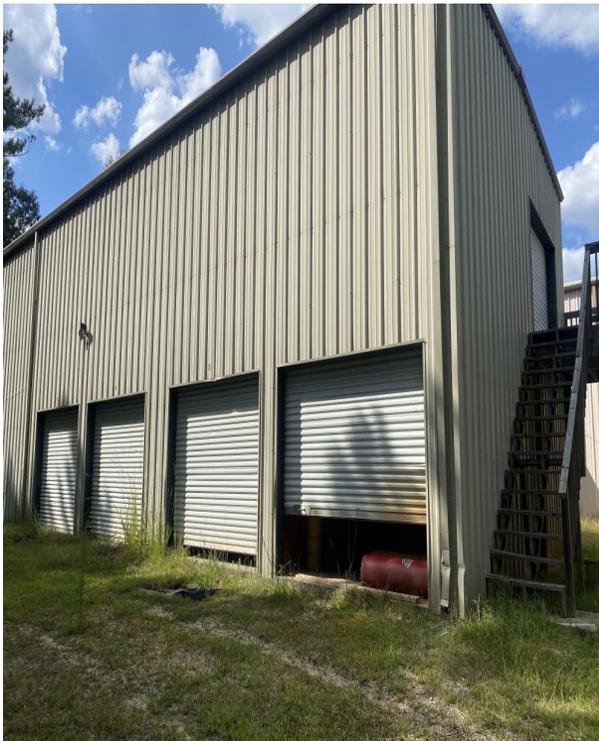
Photo 15
Comments: Auxiliary Building

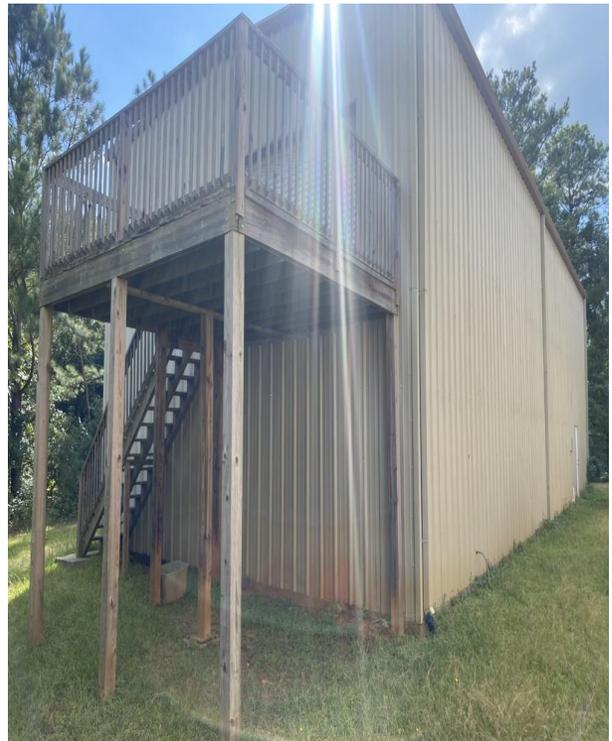
Photo 16
Comments: Auxiliary Building
