**Hazardous Materials Assessment Report
Courtesy Parkway Extension
Springfield Baptist Church - Activity Center
1875 Iris Dr SE
Conyers, Rockdale County, GA 30013**

**Corporate Environmental Risk Management, LLC (CERM)
1990 Lakeside Parkway
Tucker, GA 30084
Project No. 2023-1470D-002D**

October 13, 2023

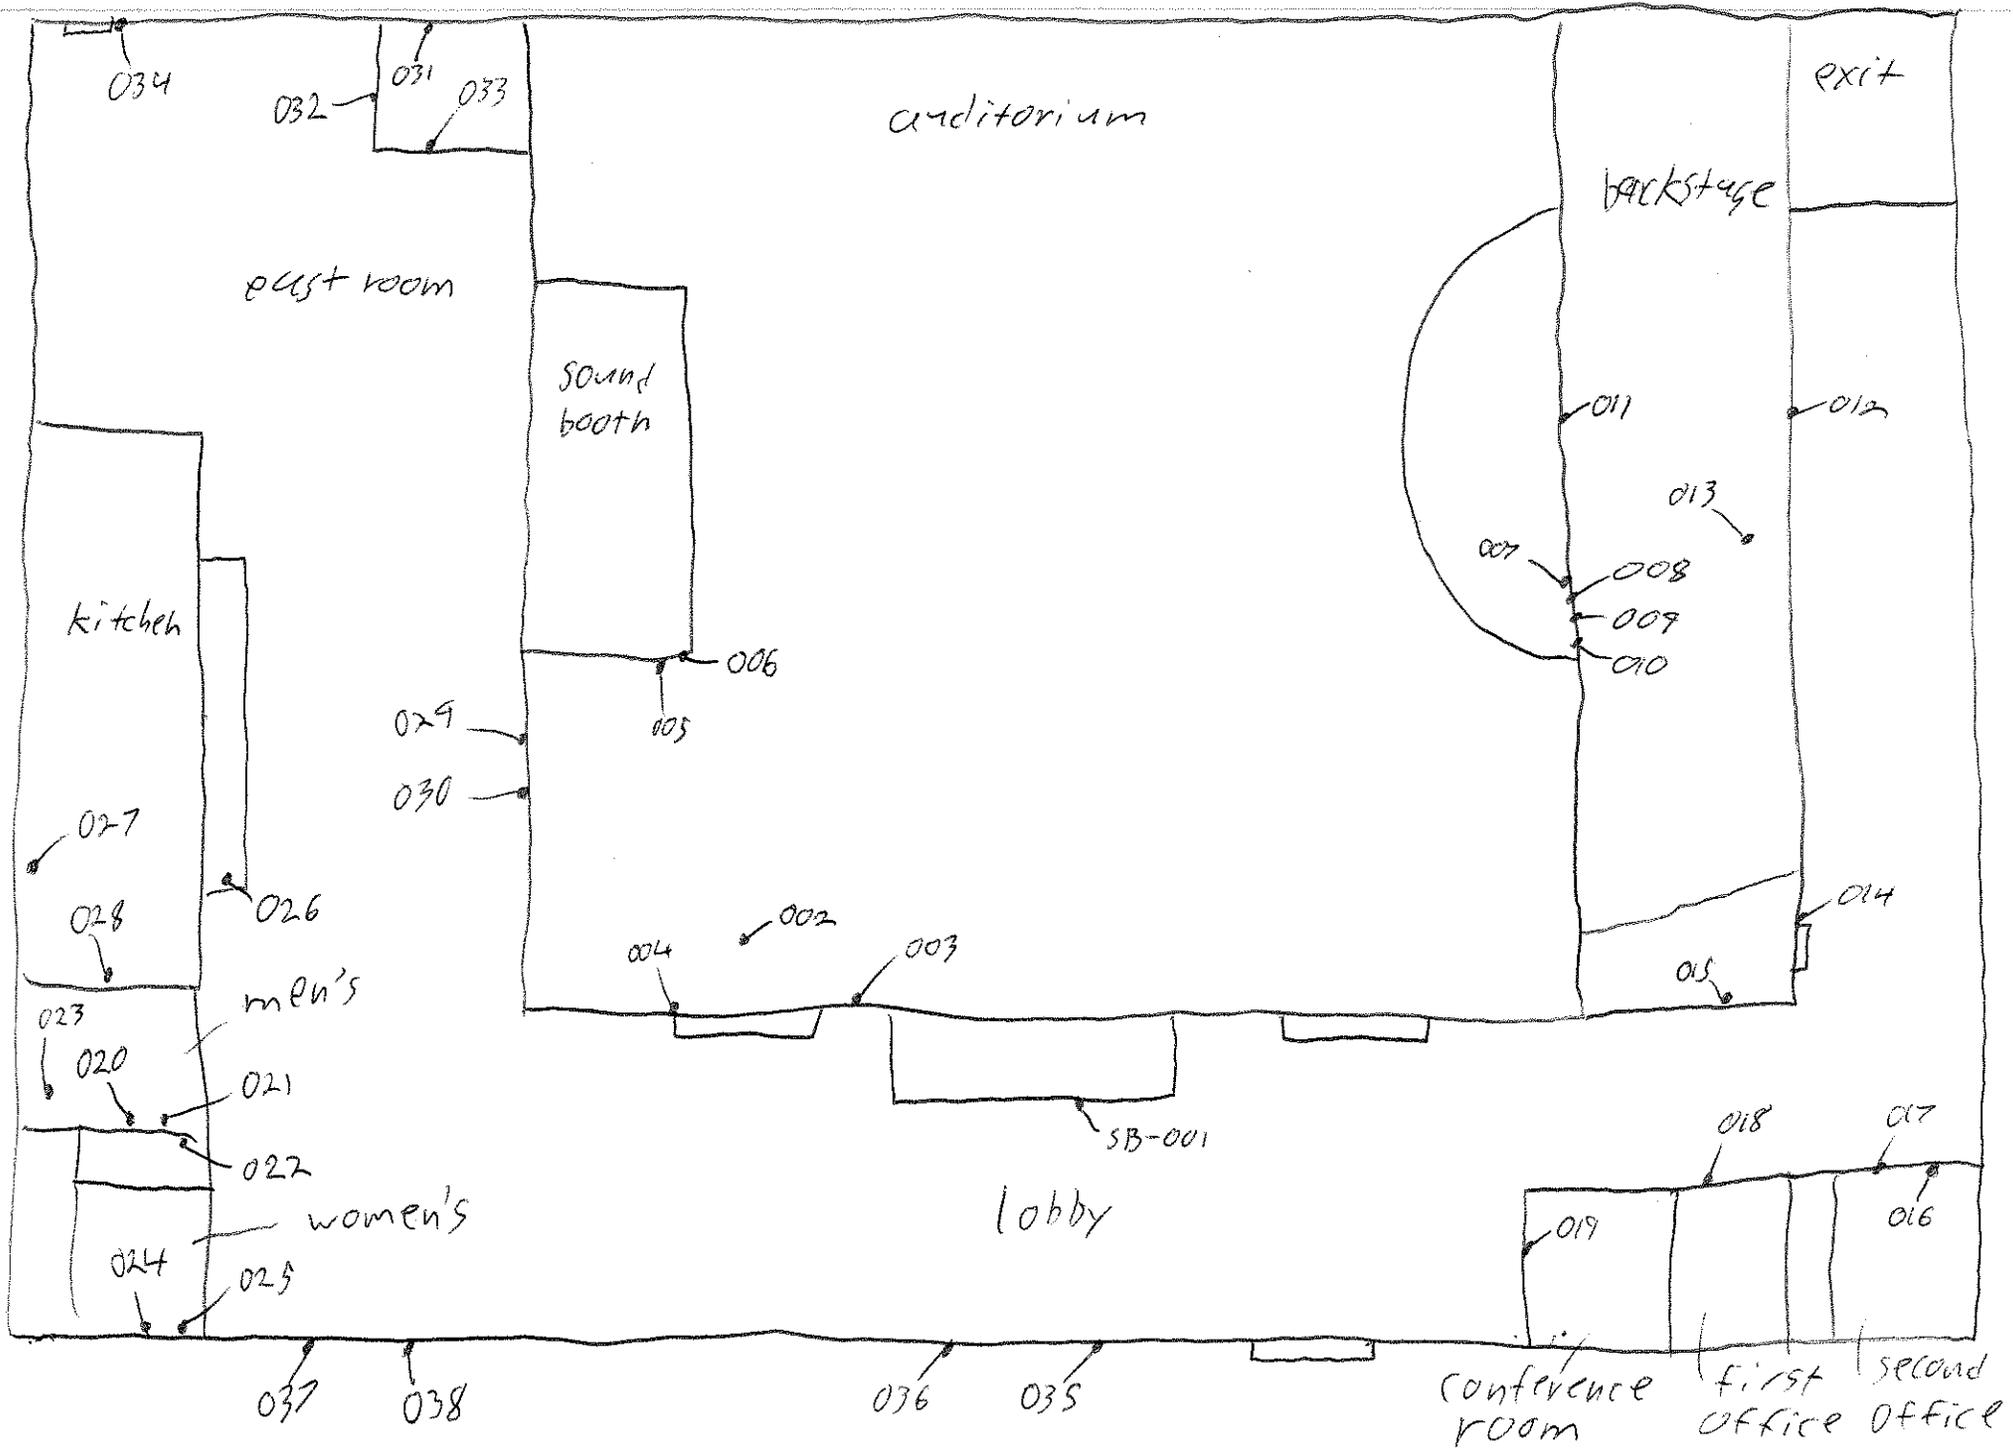
9/20 Lead Paint - Springfield Baptist XRF Readings

Lobby desk black molding	> 0.01	SB-001
auditorium floor	0.01	002
auditorium wall	0.01	003
auditorium wall door frame	0.01	004
sound booth tan	0.01	005
sound booth black moulding	0.01	006
stage decor white	0.01	007
↓ green	0.01	008
purple	0.01	009
black	0.01	010
stage back	0.01	011
backstage wall	0.01	012
backstage steps	0.01	013
backstage storage door	0.01	014
backstage storage wall	0.01	015
second office wall	0.01	016
second office doorframe	0.01	017
first office door	0.01	018
conference room wall	0.01	019
mens bathroom wall	0.01	020
mens bathroom closet door	0.32 0.10	021
mens bathroom door	0.01	022
mens bathroom stall	0.01	023
womens bathroom wall	0.01	024
womens bathroom closet door	0.01	025
kitchen bar column	0.01	026
kitchen cabinet	0.01	027
kitchen wall	0.01	028
east room white moulding	0.01	029
east room red wall	0.01	030
east room storage shelves	0.01	031
east room storage door	0.01	032
east room storage window	0.01	033
