**LIMITED GEOTECHNICAL EXPLORATION  
SOIL TEST BORINGS**

***Playground, Pavilion, Volleyball Courts, and Splash Pad  
Wheeler Park  
1400 Parker Road SE, Conyers, GA 30094***

**MEG 301287.46**

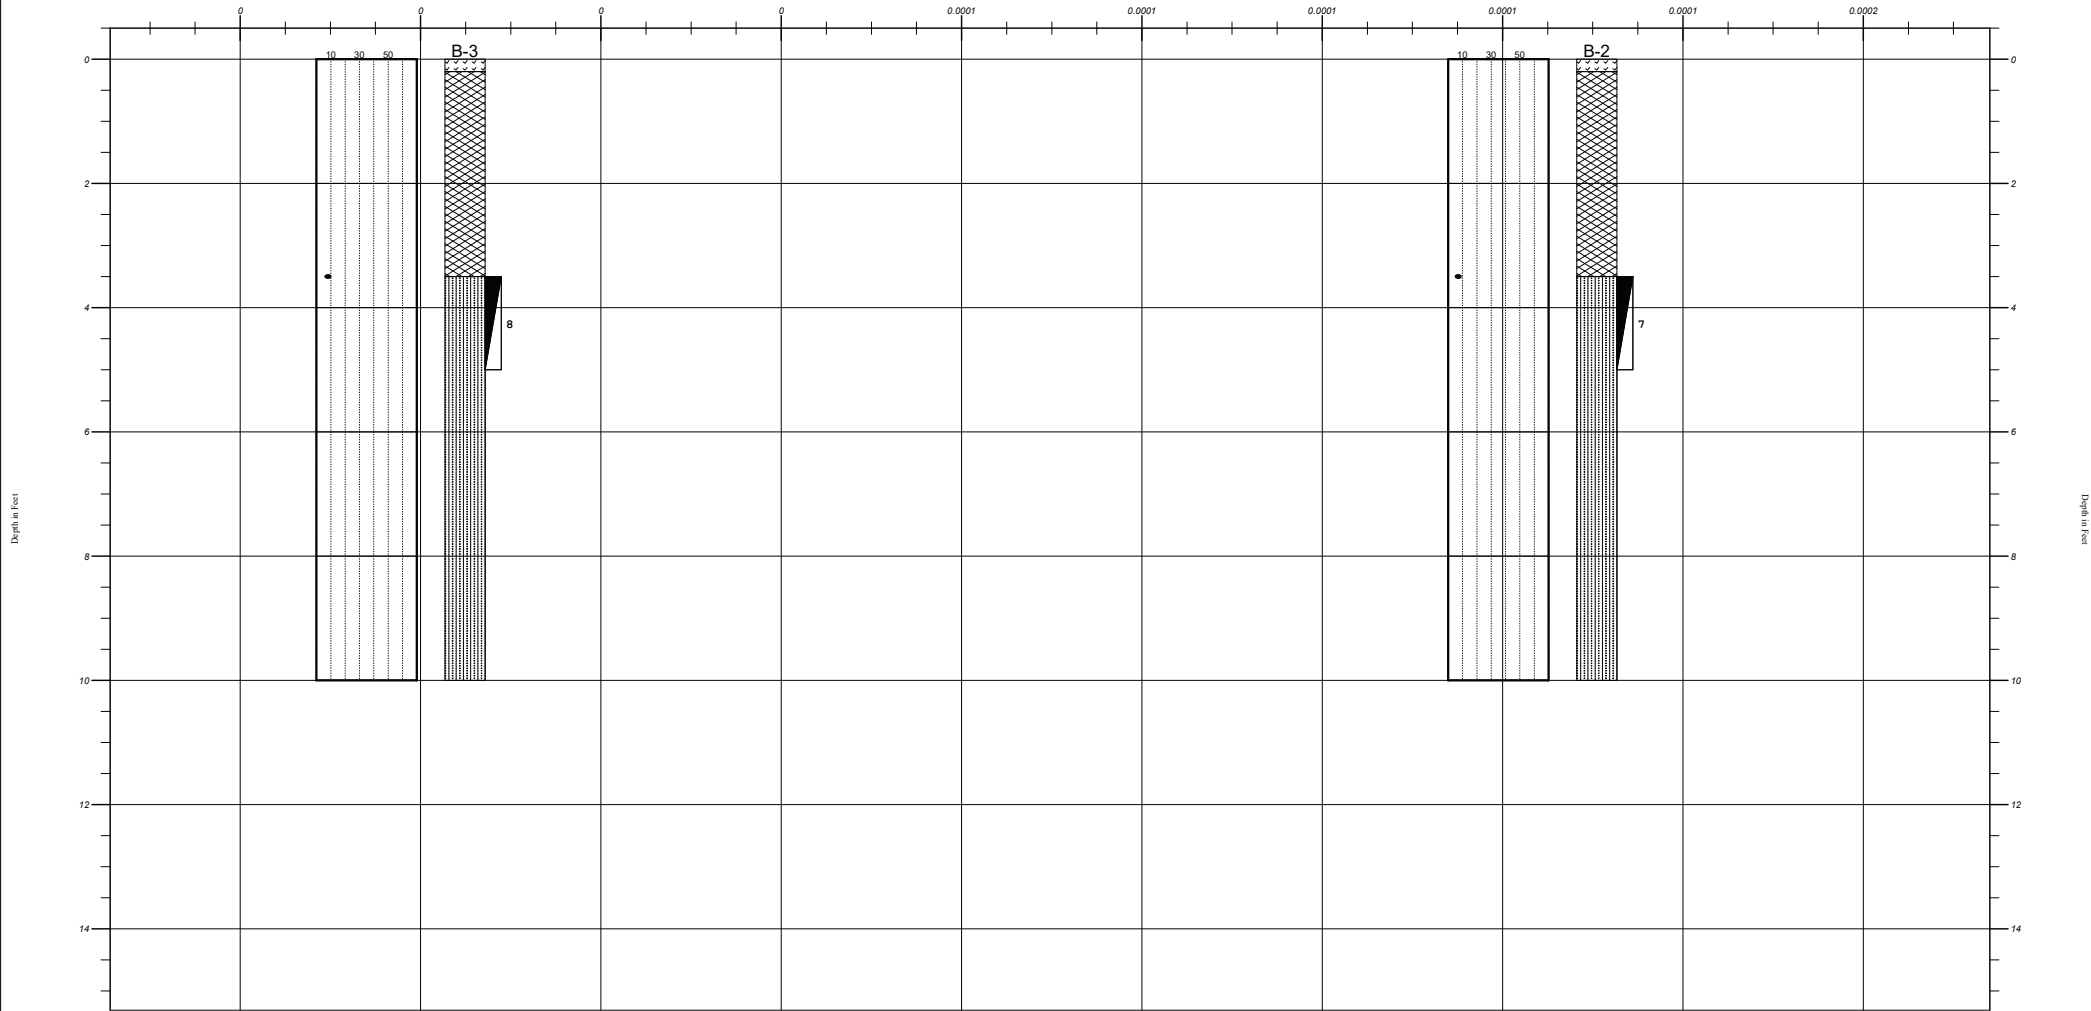
# LOG OF BORINGS A-A

Wheeler Park - Playground, Pavilion, Volley Ball Courts, and Splash Pad.

The subsurface conditions were characterized by visual-manual examination of the soils obtained from the soil test borings and observations from the auger cuttings during the auguring operations. The soil boring logs, designated as B-1 to B-12, are provided in the Appendix of this report. The subsurface conditions within the soil test borings are characterized as follows:

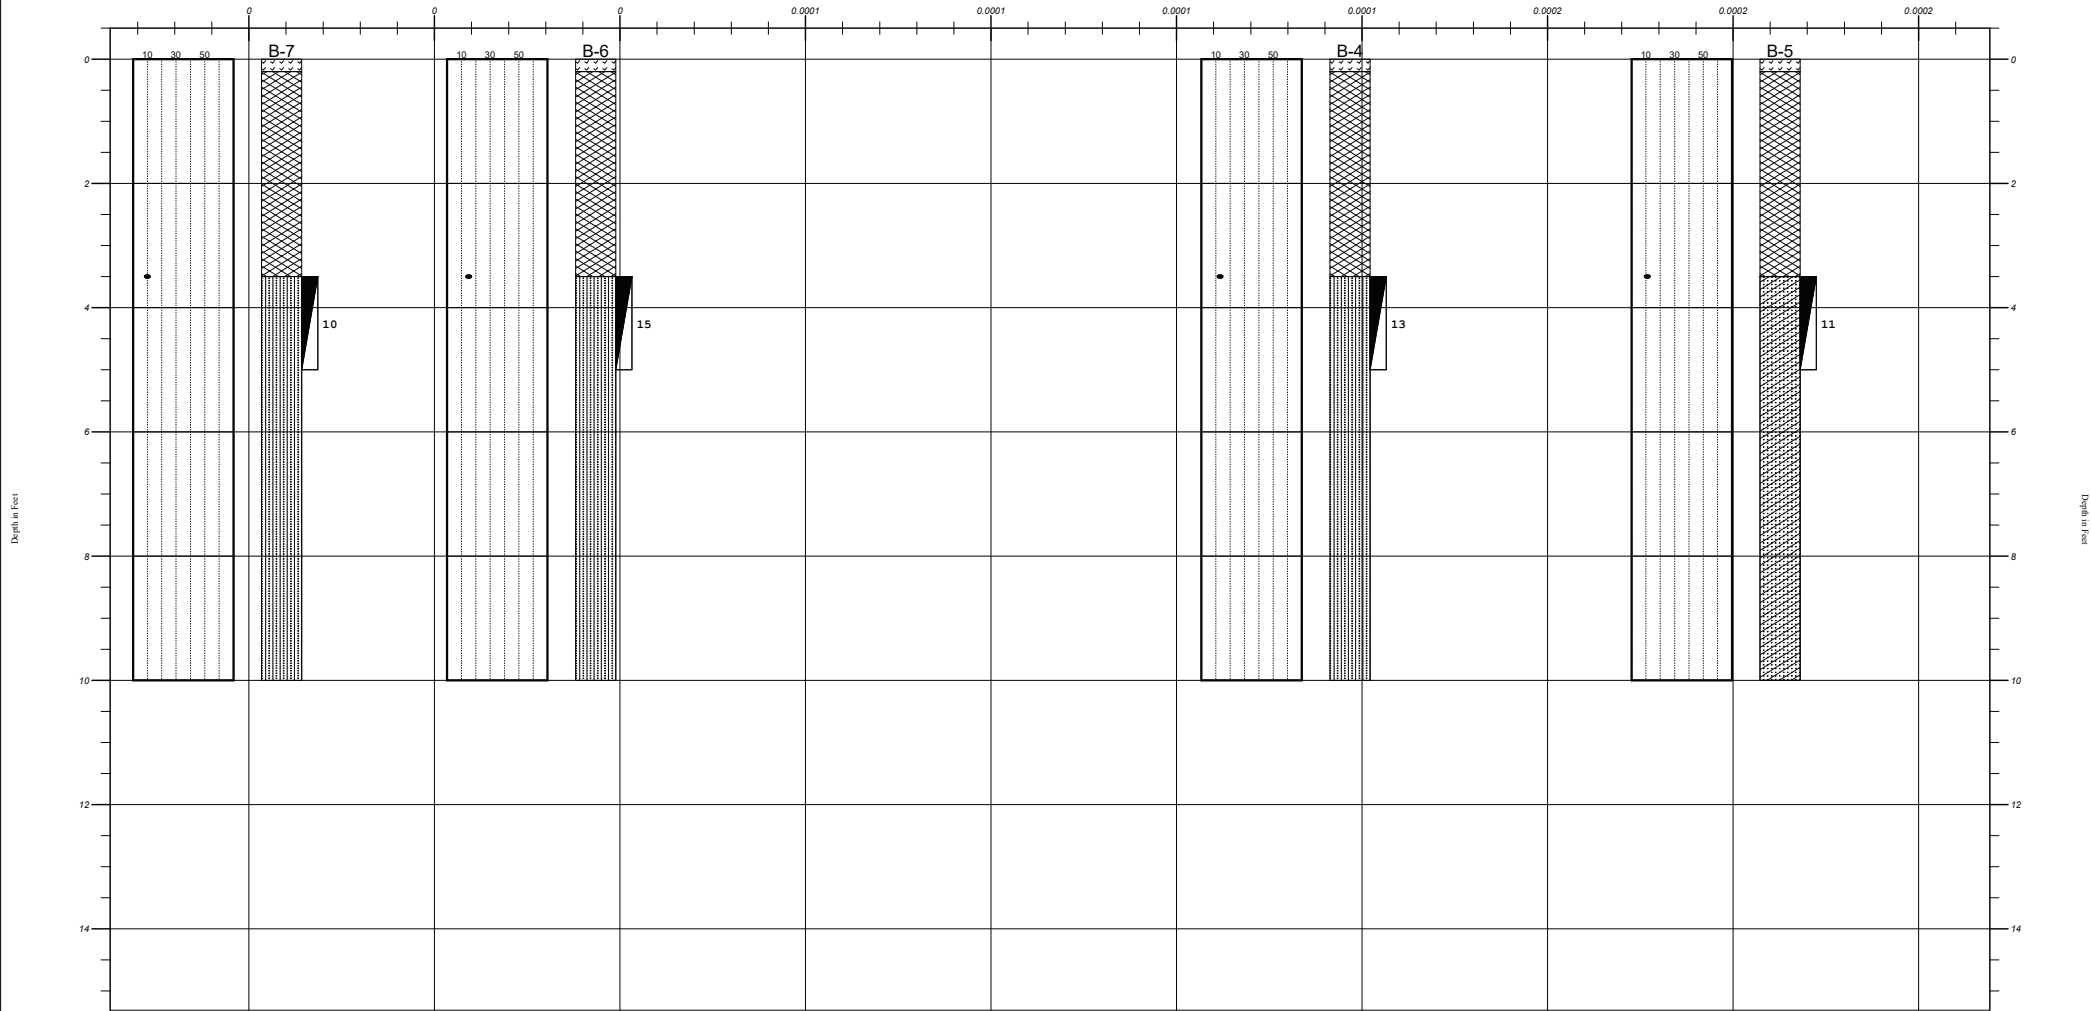
# LOG OF BORINGS B-B

- Top Soil
- Clayey sand/  
Low plasticity clay
- Fill
- Silty sand

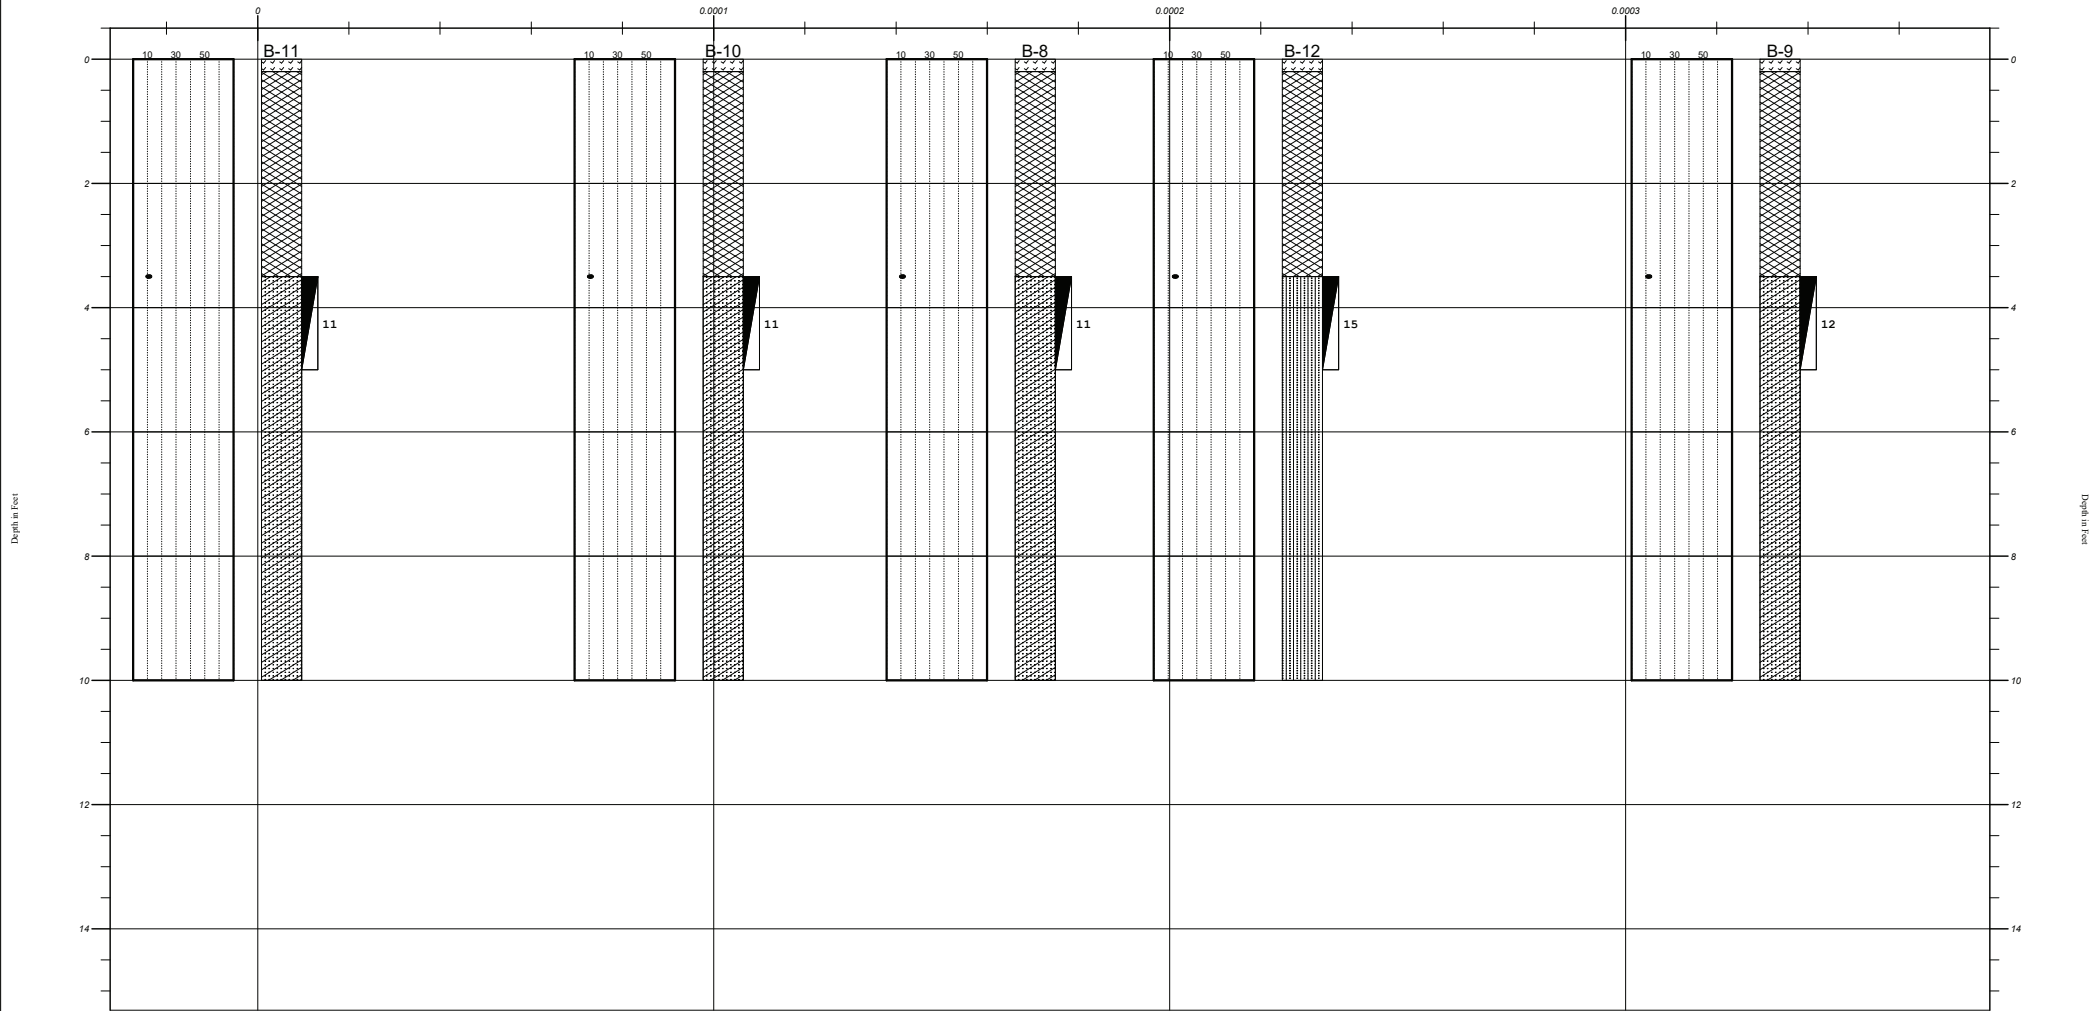
# LOG OF BORINGS C-C

- Top Soil
- Fill
- Clayey sand/  
Low plasticity clay
- Silty sand
